**BUS RAPID TRANSIT CORRIDOR (PART 2)
MOOLCHAND TO DELHI GATE JUNCTION**

**BICYCLE INFRASTRUCTURE AND SAFETY
BASED ON CYCLE AUDIT**

CONDUCTED ON 19th June / 26th June / 1st July 2009

DIMTS Ltd.

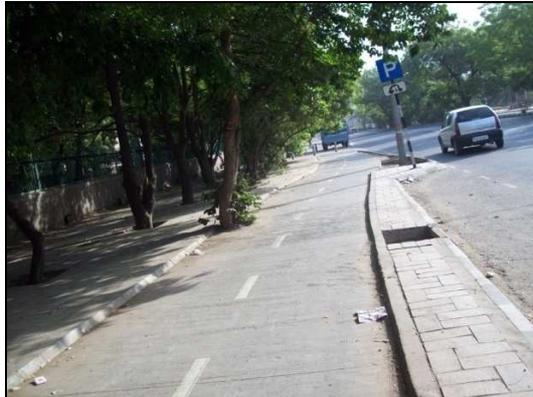
3.1.1 6200 LHS - TSR parking- No raised area in Cycle track

PROBLEM IDENTIFIED	Wheelchair accessibility to raised crossing not provided (as seen in the first part of the corridor – Part A). This is in the form of a raised crossing across bicycle track with gentle 1:20 ramps for cyclists.
IMPLICATION	TSR parkings not accessible or disable friendly.
SOLUTION	Proper detail designs as per BRT – 1 can be followed to complete TSR parking

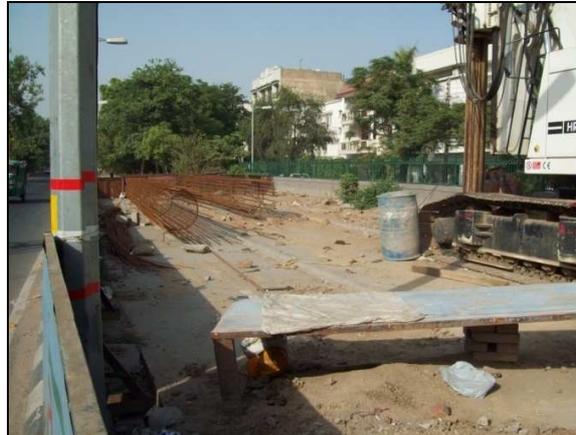
PROBLEM IDENTIFIED	Construction Activities block the cycle track
IMPLICATION	Cyclists do not re-enter the segregated facility already in place towards Delhi Gate and will be on the carriageway with buses and other mixed traffic in unsafe conditions.
SOLUTION	Construction plan can integrate facilities for cyclists and pedestrians for this zone and minimum clear and segregated pathway provided for the same

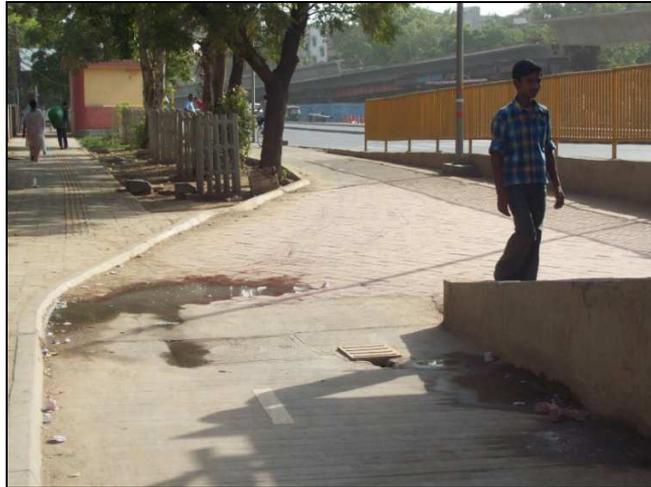
PROBLEM IDENTIFIED	Shoddy work behind the subway. A guiding block used to cover drainage glitches. Water collection at base of ramp.
IMPLICATION	Adds to uncomfortable riding experience
SOLUTION	Correction in slope and surface finishes Are required as per detail drawings

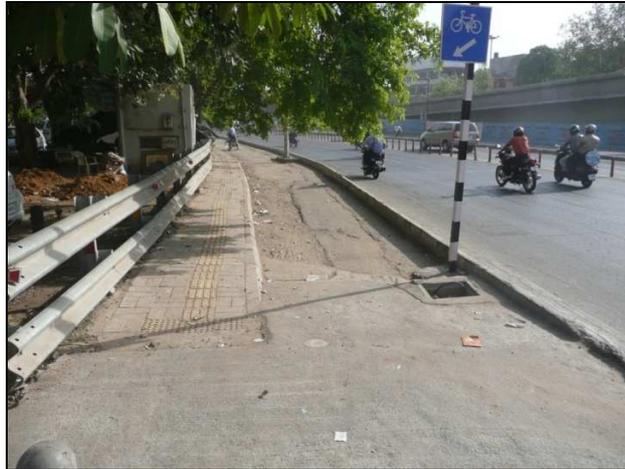
PROBLEM IDENTIFIED	Entry to the segregated facility at Rail Over Bridge (ROB) has sharp entry slope and bad or unfinished surface leading to extremely poor riding quality and uncomfortable journey for cyclists
IMPLICATION	Cyclists discontinue the use of segregated facility at this point and continue on the carriageway
SOLUTION	During the Audit on July 01 with Traffic Police, DIMTS, Rites and TRIPP representatives it was agreed that correction in slope and re layering of the concrete surface. as per standard bicycle infrastructure design details is required.

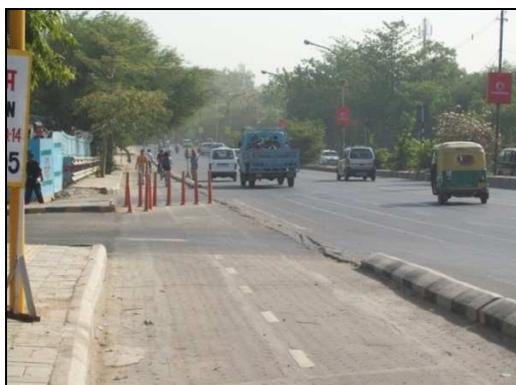
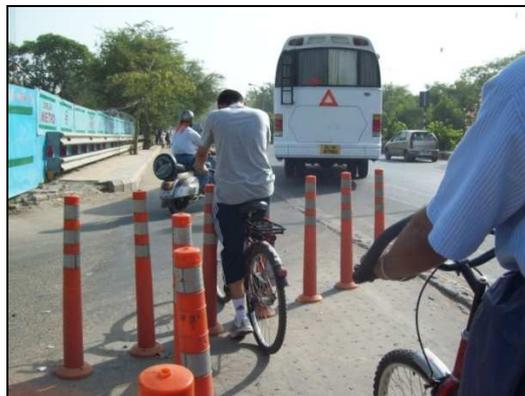
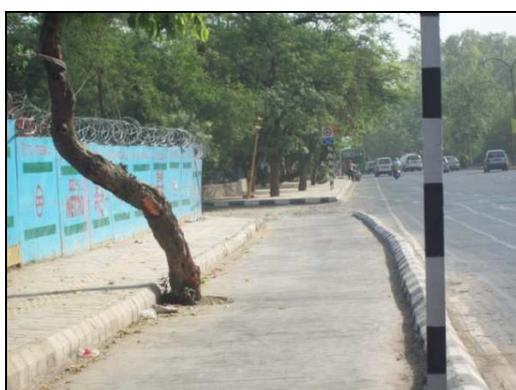
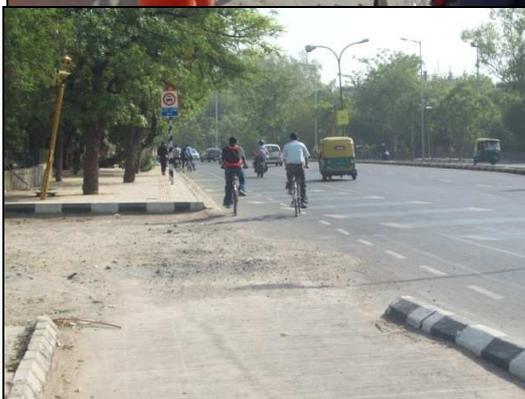
3.1.5 7880 to 7990, LHS Jungpura entrance

OBSERVATION

The cycle facility is interrupted by two entrances - one created by DMRC - now used for entering jangpura and the other an existing entrance for to enter jangpura – now used by DMRC vehicles for the construction of the CGO station.

At the first entry points, plastic bollards at 60cm c/c block the bicycle track, making it discontinuous beyond this point. It was observed during the audit that DMRC has constructed the first entry point as a diversion during construction. However both entrances continue to be used.

IMPLICATION	Lack of raised crossings is a safety hazard for cyclists.
SOLUTION	<p>A raised crossing with 80mm interlocking tiles (red color) as used in other parts (especially in BRT – 1) should be incorporated with gentle ramp in 1:12 to 1:20 slope for cyclists and steeper ramps in 1:8 to 1:10 slope for cars. Adequate Signages as per design (detail no. 27 of the design drawings) to be incorporated.</p> <p>Segregated bicycle infrastructure should be continuous (and not discontinued beyond second entrance (to Jangpura). One possibility is to</p>
REMARKS	The need for a raised crossing was especially highlighted as basic safety requirement by ACP, Traffic Police.

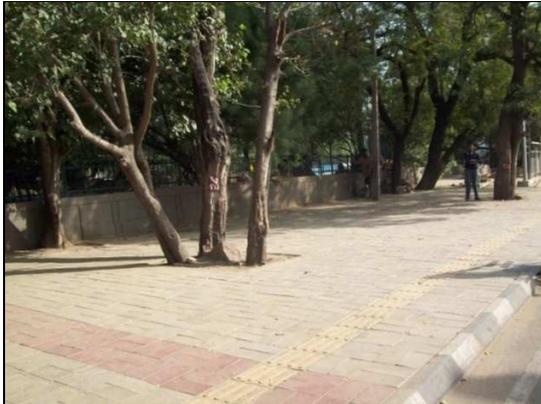
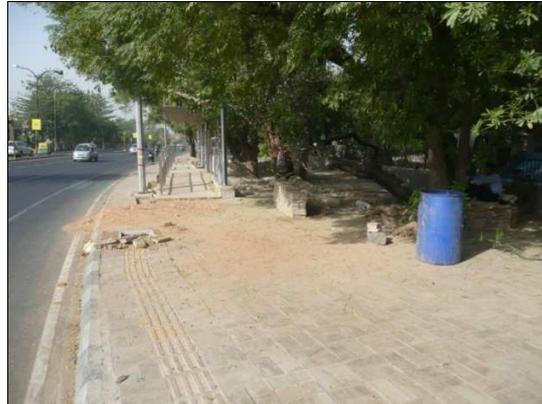
OBSERVATION / PROBLEM IDENTIFIED	<p>The cyclists are using the painted facility which is unsafe. They are next to the bus lane and a bus shelter is on this stretch. With buses stopping and people boarding and alighting the shelter, cyclists overtake the bus from the right coming in conflict with fast moving traffic coming from the ROB.</p> <p>It was informed by Mr. Gandhi that there are plans of a segregated facility for cyclists with the central shelter and land acquisition was to be taken up. However in the meanwhile the possibility of using the pedestrian path as shared facility by cyclists and pedestrians (for this short stretch) along with paint marking and signage as per design is plausible. The same is included in the drawing also.</p>
IMPLICATION	<p>High safety risk to cyclists using painted cycle track. Cyclists in painted track would also disrupt the use of bus shelters and bus lanes.</p>

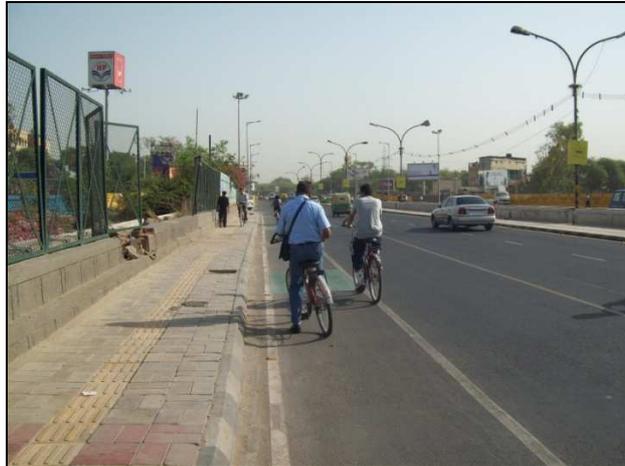
PROBLEM IDENTIFIED	The cycle track is painted over the nala.
IMPLICATION	Unsafe.
SOLUTION	The segregation needs to be kept. This could be done by the use of elevated marking/fluorescent markers (cats eye). Segregated cycle tracks proposed in the designs for this location was rejected due to limitations in bridge expansion.

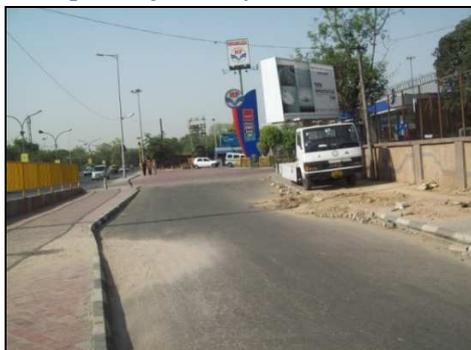
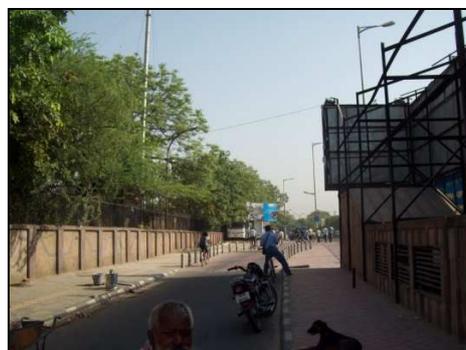
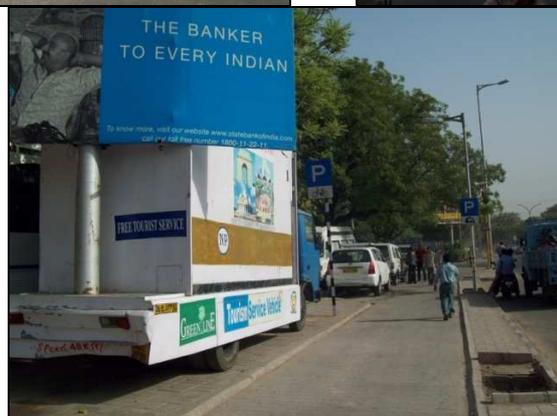
<p>OBSERVATION / PROBLEM IDENTIFIED</p>	<p>The cyclists need to get onto a raised crossing which is in front of the petrol pump and share the ROW with the pedestrians before they move ahead to the stretch near the subway. It is observed that due to cars waiting to access petrol pumps, the raised area is blocked for cyclists and therefore they mix with motor vehicles on the carriageway.</p> <p>It was observed that the service lane at the rear was not being used at all for access by motor cars. Instead it is merely used for illegal parking, which also occupies, pedestrian path and bicycle track.</p> <p>Ahead of the subway, the cycle track is segregated and an at grade access for wheelchairs provided. The rickshaws are seen parked on the road at the CGO node.</p>
<p>IMPLICATION</p>	<p>High risk for cyclists using painted cycle track.</p>
<p>SOLUTION</p>	<p>Continuous segregated infrastructure from the raised crossing in front of petrol pump till the road crossing (entrance to CGO complex) should be provided. As informed by Mr. Gandhi drawings for this design already exist and can be</p>

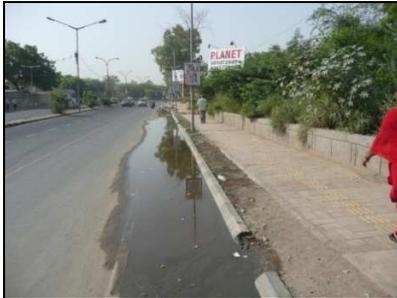
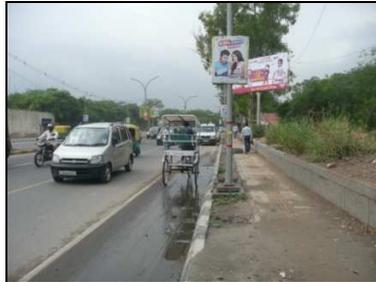
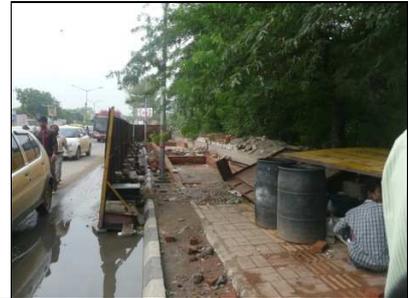
OBSERVATION / PROBLEM IDENTIFIED	1.2m wide painted bicycl lane along side painted bus lanes provided from chainage 8380 – 8650. High pedestrian volume on narrow pedestrian paths was observed along with two way movement of cyclists on the painted tracks. ACP traffic police pointed at the potential risk to the life of cyclist, especially because it is on a sharp bend at this location.
IMPLICATION	High accident risk for cyclists using painted cycle track.
SOLUTION	<p>ACP, Traffic Police that some sort of segregation is required to make the cyclists safe. He suggested taking them over the footpath since in his view taking space from carriageway here was not a practical option.</p> <p>RITES representative informed him that the footpath is not very wide as the stretch is along a disputed land and cannot be acquired.</p> <p>Mr. Gandhi suggested that sharing of bicycle and pedestrian facility is a mere theoretical exercise which may not result in actual use. He suggested that instead a 30cm wide curb could be used at the painted line, and a minimum 2.0m wide bicycle track (between the light poles) provided by acquiring the unpaved area between poles and some space from the carriageway.</p> <p>Other means of segregation that may be used are plastic bollards and raised markings (reflectors). Plastic bollards even if used at considerable distances may discourage fast moving vehicles from entering bicycle infrastructure. Though this may not be sufficient to ensure bicyclists safety and prevention of encroachment by stopping vehicles.</p> <p>In case segregation is not possible here the only other means of ensuring bicycle safety is to reduce speed of motorized vehicles to 30Km/hr., through the adequate use of speed breakers, rumble strips or other design means.</p> <p>Bus shelter encroaching pedestrian path, may be used for through movement of pedestrians in the absence of dedicated facility for them.</p>

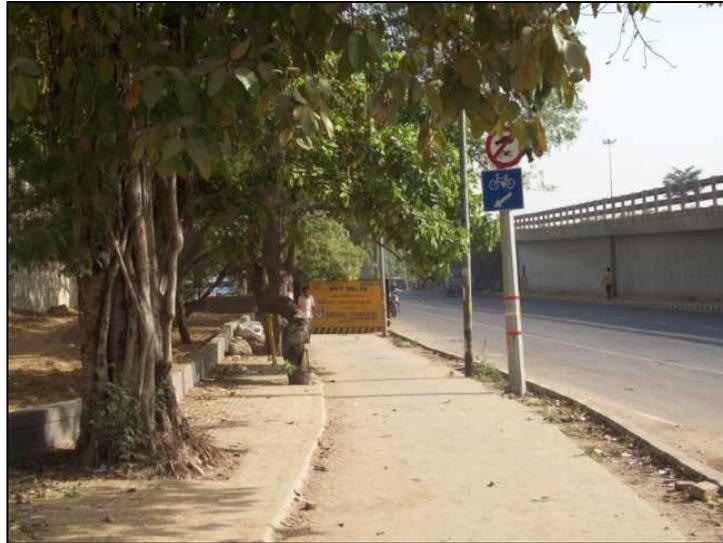
PROBLEM IDENTIFIED	The bus shelter is constructed on the segregated cycle track. Cycle infrastructure is abruptly disrupted and discontinued here..
IMPLICATION	It is a visual obstruction, a clear encroachment over already constructed bicycle infrastructure. Cyclists move out onto the carriageway and merge with carriageway traffic to cross the junction 100m ahead. Making it unsafe as this gets them to a conflict with the buses.
SOLUTION	<p>A number of simple solutions exist for this location. One of the following may be chosen:</p> <p>A bus shelter may not be provided here and a simple pole marker for bus stop with space created on the unpaved for passengers to stand may be created.</p> <p>Bus shelters are only required here for turning buses, the same may be located after the left and right turn and thus this shelter may be removed.</p> <p>Proper concrete bicycle infrastructure is continued around the bus shelter using gentle bends to ensure both visual and physical continuity. Wheel chair access to shelter may be ensured by providing at grade wheelchair crossings (3m wide) across cycle track like the ones which already exist in BRT-1.</p>

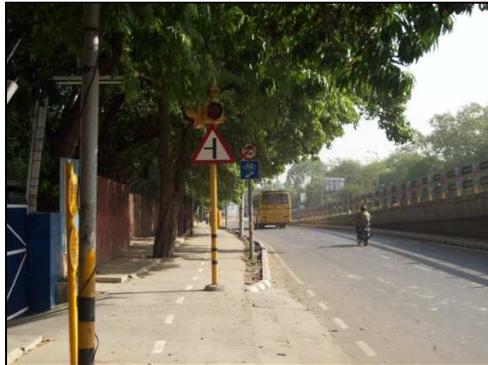
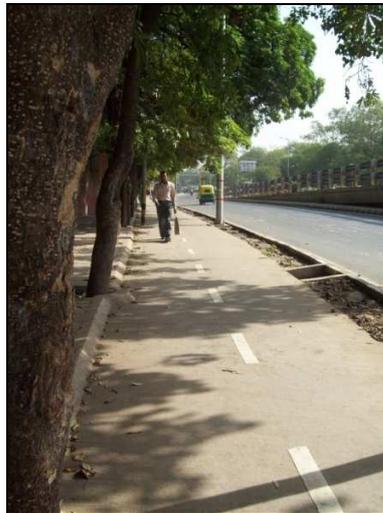
3.1.12 9100 LHS - Pole and Trees Restrict Footpath and cycle track

PROBLEM IDENTIFIED	Blinker pole obstructing the cycle track. Narrow pavement and trees outside Blind School creates conflicts between cycles and pedestrians and also limits clear usable space for both.
IMPLICATION	The cyclists could move on the carriageway, mixing with vehicles which may result in fatal accidents.
SOLUTION	Simple solutions could restore the use of a well constructed and conceived segregated track here, These are: Blinker pole should be shifted / removed from the cycle track Where trees restrict the width of bicycle path, the same may need to be removed or the bicycle path widened into the unpaved for these short stretches. Retro-reflective stickers should be provided on trees. Use of tree guards was also suggested by TRIPP representatives to get additional width on footpath and retaining breathing space for trees. The pointed out that detail drawings for the same existed.

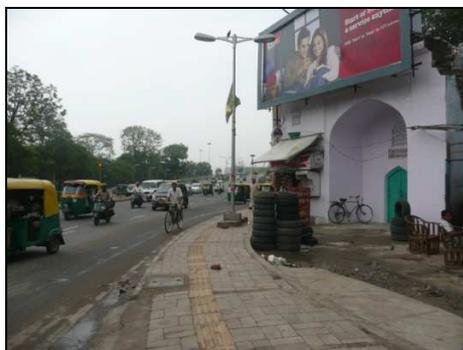
3.1.13 9200 LHS - Discontinued Cycle track. Cyclists share space with buses on the carriageway.

Problems Identified	<ol style="list-style-type: none"> 6. Segregated cycle track in front of blind school and in front of Oberoi is discontinued here at chainage 9200 due to constrained ROW at Mosque. 7. Taxi parking occupies footpath and service lane near gate before mosque 8. There is a pole located in middle of footpath 9. The slope of ramps in the pedestrian path do not comply to the ratio of 1:12 – 1:20 10. No raised crossing with interlocking tiles in front of oberoi hotel gate.
Implications	Cyclist mix with high speed and weaving motorized traffic at the bottom of the flyover, putting them in risk of accidents.
Solutions	The 1.8m wide pedestrian path can be shared for this distance of 25-30m by cyclists (at the mosque). This can be achieved by providing them with gentle 1:20 ramps to reach the pedestrian path, including adequate signages and removing the lone light pole standing in the middle of the pedestrian path at this location.

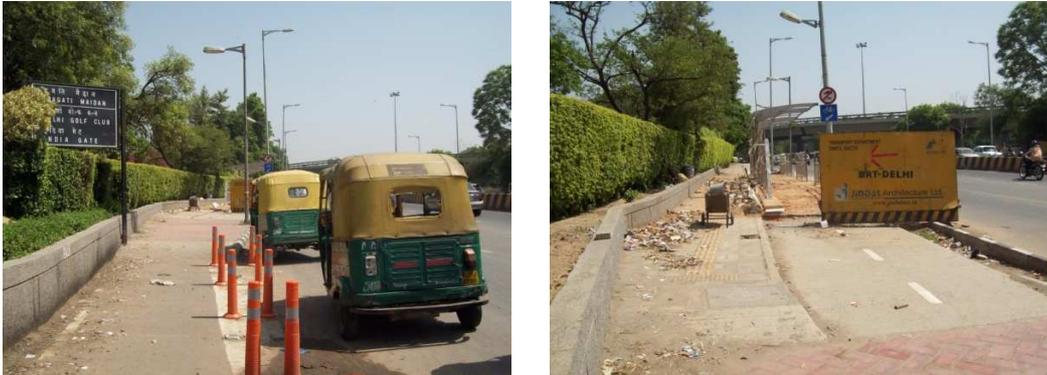
<p>PROBLEM IDENTIFIED</p>	<p>Continuous cycle track from Lodhi Road Junction all the way upto Oberoi is disrupted at the Mosque and Oberoi entrance. The footpath in front of Oberoi hotel entrance is also discontinued . Pedestrians and cyclists use the edge of the carriageway and have to weave towards the moving fast traffic coming down from the flyover due to parked cars on the side of the road. The pedestrians include here a higher share of differently-abled due to the BLIND SCHOOL – 250m from this place.</p> <p>The bus shelter is constructed on the segregated cycle track. Cyclists move on the carriageway. The bus shelter effectively destroys the continuity and usability of a well constructed bicycle infrastructure here.</p>
<p>IMPLICATION</p>	<p>High risk of accidents for pedestrians and cyclists from traffic from the flyover which also weaves with traffic coming from Lodhi Road Junction. Bicycle infrastructure is discontinued by the presence of bus shelter on it. This clearly puts cyclists in the lowest priority for planners, making cyclists loose</p>

<p>REMARKS</p>	<p>It was seen as an encroachment in the cycle track. The Traffic Police also commented on such actions. They saw this as a redundant effort and did not see the reason of why a formal big shelter is required to run left lanes. This could also work by installing a signage indicating a bus to stop since the entire action has been done to experiment the center and the left lane of the BRT.</p> <p>Also regarding the entry into the cycle track blocked by vehicles/ taxi's in front of oberoi hotel, he observed that strengthening of enforcement was required at this place.</p> <p>The police also expressed their concern on the discontinuity and unusability of footpath.</p>

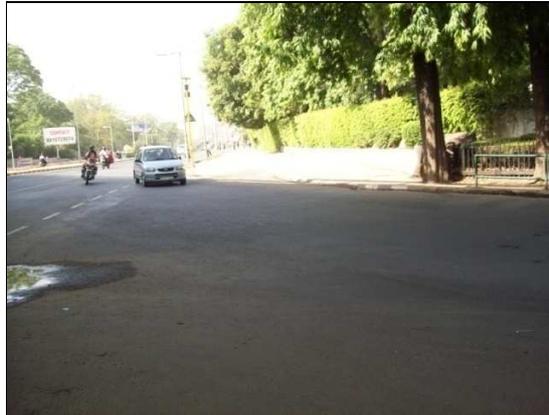
PROBLEM IDENTIFIED	Fast turning traffic into Zakir Hussain Marg from the corridor. Difficulty in crossing the road by pedestrians and cyclists.
IMPLICATION	Safety hazard to cyclists going straight from the turning vehicles.
SOLUTION	A raised crossing (as per BRT standards of detailing) with 80mm interlocking tiles (red color) as used in other parts should be incorporated with gentle ramp for cyclists and steeper ramps for cars. Use of blinkers and advance warning signages recommended.
REMARKS	The police agreed to the need of a raised crossing that has already been used at other places in the corridor. The turning traffic was high speed and needed to be slowed down for the safety of bicyclists and also make the footpath continuous. The police also felt that the use of a short pedestrian and cyclist signal may also be desirable at this location (along with the raised crossing with gentle slopes for cyclists and sharper ramps for cars).

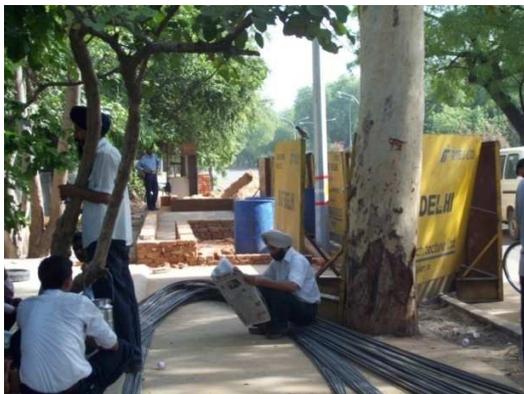
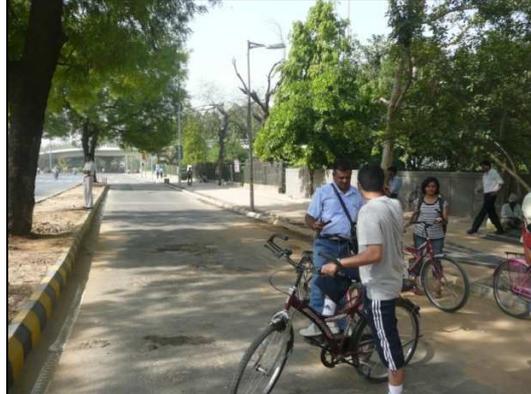
PROBLEM IDENTIFIED	The bus shelter is constructed on the segregated cycle track almost 10m away from the bus lanes
IMPLICATION	Continuity of a very good bicycle infrastructure is broken yet again, forcing cyclists on to the carriageway even when a good facility exists. Bus passengers would need to get off on to a service lanes, cross raised segregation between service lane and bus lane to access the buses.
SOLUTION	<p>The traffic police said that it would be very difficult for the buses to weave into this bay and come out again. They can stop in the bus lane for boarding and alighting passengers. There is an island already in place with dense trees which would act as a bus shelter if a simple sign board and route map is provided along with some paving for commuters. The service lane may be discontinued here as it is not being used. Here Mr. Gandhi commented that this service lane has been created because of central bus shelter requirements of additional width, and is thus not required currently for the side bus lane experiment. Thus here pedestrian access across bicycle track and discontinued service lane may be provided till the bus lane. The pedestrians can come into the shelter from the footpath at the rear. This would retain the continuity of bicycle infrastructure.</p> <p>Mr. Gandhi also commented this shelter as so many others constructed are not as per design. He added that even if a segregated bus lane was desired here, the bus shelter could easily be constructed on the service lane along with improved alignment leaving one lane free for buses.</p> <p>Also here Ruchi informed the auditors that no shelter was proposed in the drawings at this location, and only a platform with sign post was mentioned in the drawing, and hence the same drawings may be followed.</p>

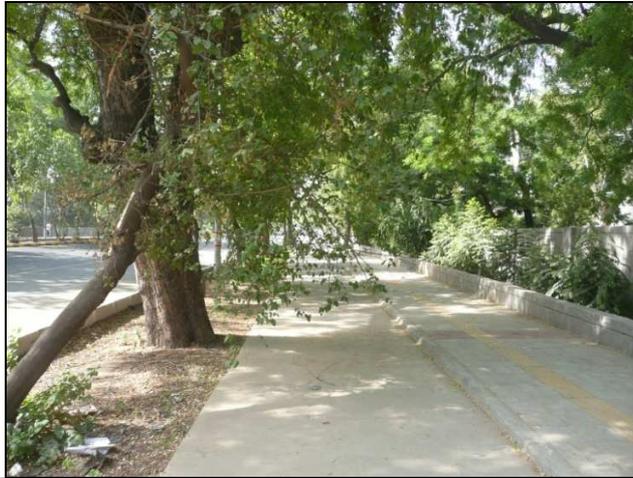
PROBLEM IDENTIFIED	Tree branches at eye level or even below would hit the cyclists providing discomfort while riding
IMPLICATION	Mainstream commuters may opt out of segregated facility.
SOLUTION	Maintenance plays a vital role. Needs to be taken up at a regular interval.

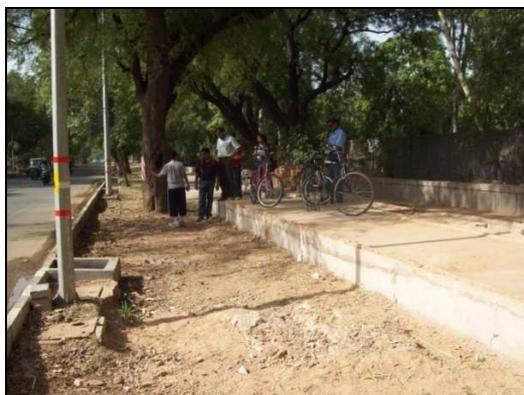
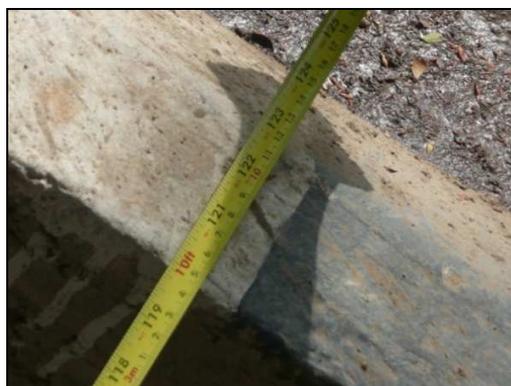
3.1.18 10060 LHS - Side shelter on Cycle Track

PROBLEM IDENTIFIED	A 1.7m bus shelter constructed on the segregated cycle track 3.2m away from the carriageway.
IMPLICATION	The space in front of the cycle track is more than the cycle track and closer to the carriageway. A bus shelter could have been easily constructed onto the unpaved areas as seen in the photograph. This is completely ruining the usage of a well constructed, shaded cycle track. If it has been done to ensure level boarding and alighting, the right space is the unpaved area which is 3.2m wide and exact required width is available between trees.
SOLUTION	Relocating this shelter and placing it in the unpaved area.
REMARKS	<p>All auditors(excluding RITES) agreed to the fact that there was no reason of constructing it on the track.</p> <p>It was seen as an encroachment in the cycle track. The Traffic Police also commented on such actions. They saw this as a redundant effort and did not see the reason of why a formal big shelter is required to run left lanes. This</p>

could also work by installing a signage indicating a bus to stop since the entire action has been done to experiment the center and the left lane of the BRT.

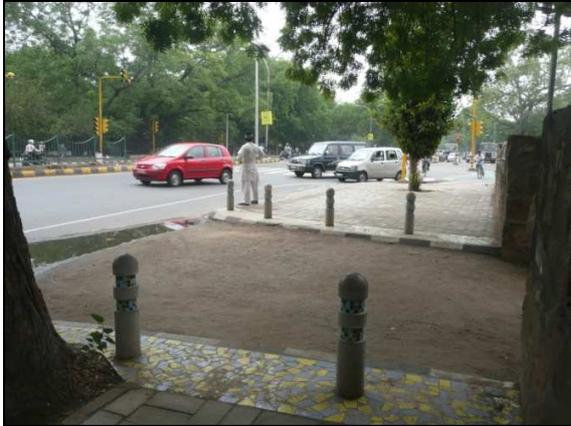
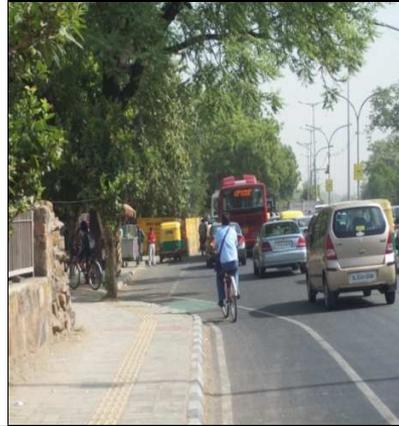
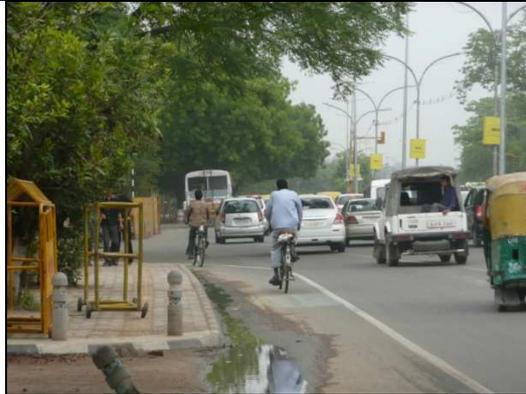
<p>PROBLEM IDENTIFIED</p>	<p>The footpath is discontinuous (raised crossings for wheelchair do not exist at many places). After the S B Marg junction (10600)the cyclists are in a painted lane. 100m down the corridor a segregated cycle track is made at the rear of the footpath but it is not visually clear and a major detour for the cyclists. The entry to the cycle track is also not direct and smooth to enter the track and cyclists miss the entry and prefer going straight. No information through signages on changing conditions. The traffic flow was not even occupying the left most lane including the buses.</p>
<p>IMPLICATION</p>	<p>Cyclists ride next to the side bus lane which is unsafe. Once they miss the entry they again would need to weave across the left turning traffic .</p>
<p>SOLUTION</p>	<p>Continuity of pedestrian infrastructure should be retained across property entrances by providing raised crossings. Segregated bicycle infrastructure should be provided to cyclists as per standard bicycle track details used in BRT – 1. Mr. Gandhi informed everyone that drawings for the same already exists and is available with all agencies.</p>

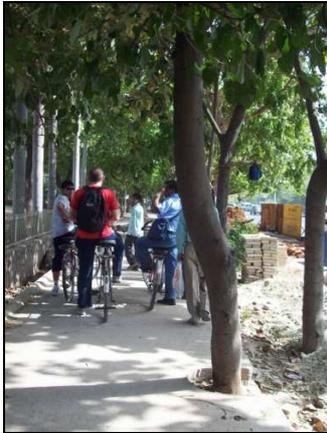
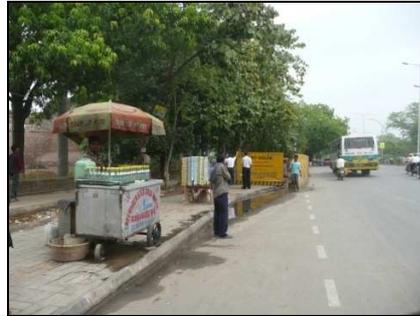
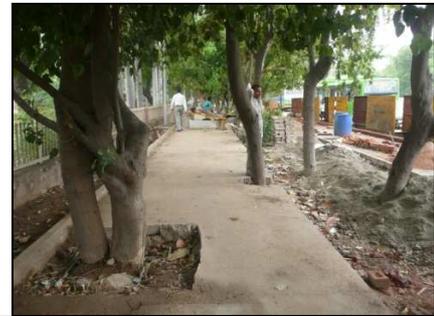
10650 LHS – Poor Condition of Segregated Cycle Track

<p>PROBLEM IDENTIFIED</p>	<p>Construction of the bus shelter onto the footpath and close to the junction. Drainage issue - water collecting on carriageway. Cycle track made in a straight alignment and weaving through trees affecting the width of the track. The drop near the trees is also dangerous. It makes it a very unattractive and unusable facility provided to the cyclists.</p>
<p>IMPLICATION</p>	<p>Even if the cyclists enter once and use this, they would easily opt out and use the carriageway instead. The current bicycle infrastructure is not only far away from the carriageway (making it undesirable for use by cyclists), its directness, coherence and comfort is far worse than the carriageway.</p>
<p>SOLUTION</p>	<p>Since the last car lane is not being used, the shelter can be constructed in that bay and a little further away from the junction and a segregated bicycle track can continue behind the shelter between footpath and the bus stop (with proper level crossing details for wheelchairs). Mr. Gandhi commented that the drawing for such a design already exists. Drainage needs to be resolved by improving slopes or collection points.</p>

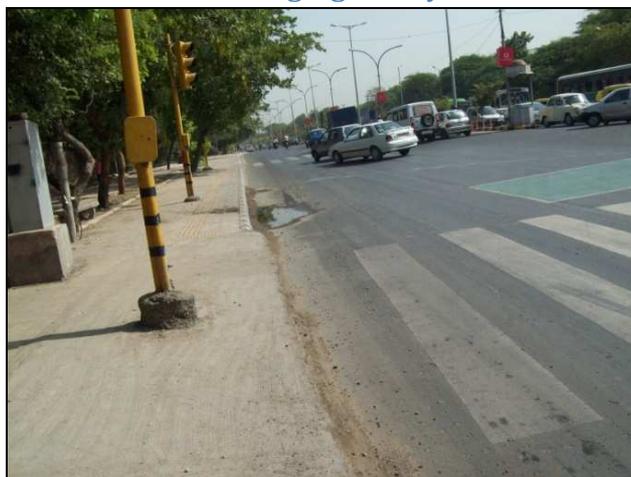
PROBLEM IDENTIFIED	There is no access for the cyclists to come onto the carriageway to cross at Bhairon Marg junction. In this stretch, the cycle track is behind the footpath. Turning cycles need to exit out and come out on the junction which is not constructed on the site.
IMPLICATION	Even if the cyclists enter once and use this, they would easily opt out and use the carriageway instead.
SOLUTION	Entry and exit to the track should be constructed with a smooth alignment. Representatives from TRIPP informed the auditors that drawing for the location showing entry and exist connections for cyclists exists and can be used. They said the drawing incorporates the best practices for doing so.
REMARKS	Traffic police informed that the junction has a high volume of traffic and the safety of turning cyclists would need to be seen critically.

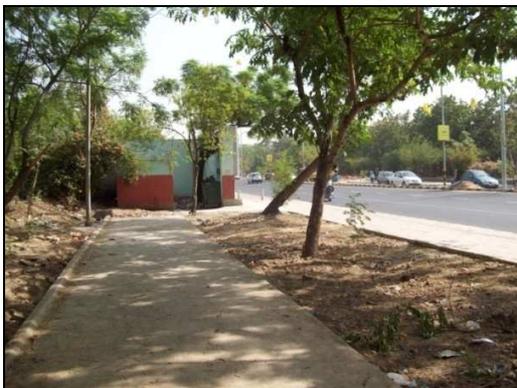
3.1.24 11400 LHS – Cycle Track Abruptly Ends at Dustbin

PROBLEM IDENTIFIED	Cycle track is obstructed by the dustbin. Temporary detour indicated is perpendicular to the flow of travel and not visual seen from a distance. No signage informing the cyclists about the dead end. RITES representative informed that a request with MCD has been sent to remove the obstruction,
IMPLICATION	Even if the cyclists enter once and use this, they would easily opt out and use the carriageway instead. Since already it is a suboptimal solution : the track is away from the carriageway.
SOLUTION	Cyclists should be informed using signages. A safe detour which is visually seen from a distance (a combination with footpath for the length of the dustbin) is preferred. The bicycle track alignment needs to incorporate minimum but gentle bends to retain its directness and coherence and thus present itself as an attractive and a usable option. Mr. Gandhi commented that the ideal solution for this situation is to provide the bicycle infrastructure along the carriageway as per design drawings. That would give it an ideal chance of being used.

REMARKS	The chances of the cycle track being used look faint because it is at the rear, away from the carriageway. A task with operations would be to introduce the facility to the cyclists has to be taken up but any kind of the obstacles should be removed to make it reliable.

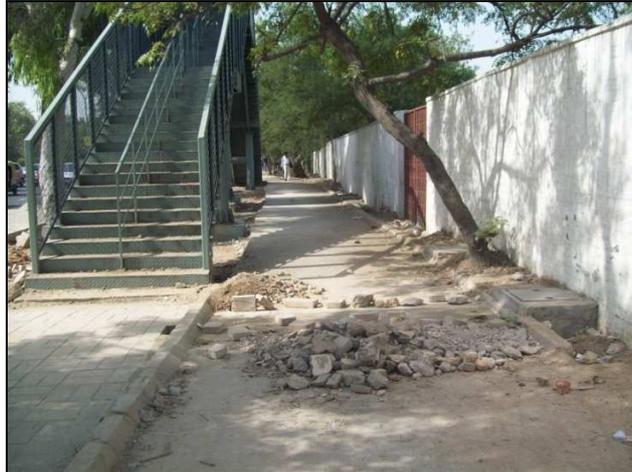
PROBLEM IDENTIFIED	Condition of cycle track behind the footover bridge. No common area at the foot of the steps to indicate the cyclists that it would be a common cycle track and footpath. The inclined trunk of the tree would hit the head of the cyclists.
IMPLICATION	Even if the cyclists enter once and use this, they would easily opt out and use the carriageway instead. Since already it is a suboptimal solution : the track is away from the carriageway, and is prone to high friction from pedestrians and hawkers, etc.
SOLUTION	Cyclists should be informed using signages. Common area should be indicated.
REMARKS	The chances of the cycle track being used look faint because it is at the rear, away from the carriageway. A task with operations would be to introduce the facility to the cyclists has to be taken up but any kind of the obstacles should be removed to make it reliable.

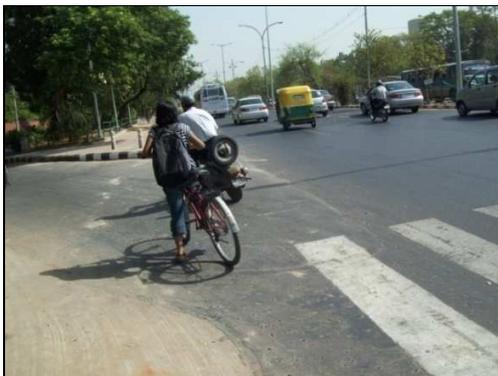
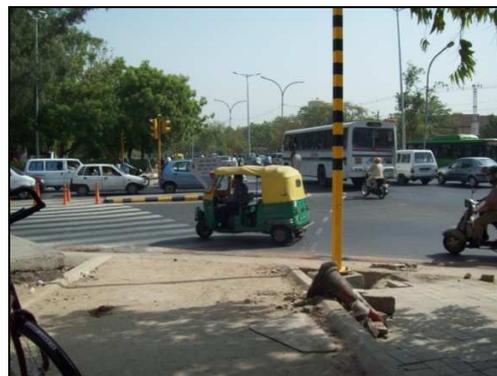
PROBLEM IDENTIFIED	The exit of the cycle track is unfavorable for usage by the cyclists. Left turning vehicles constantly cross. The ramp of the exit is also very steep and ends directly into the junction. This makes it unsafe to use both for pedestrians and cyclists.
IMPLICATION	The cyclists take much more time to cross the segment from the segregated infrastructure than using the carriageway. Even if the cyclists enter once and use this, they would easily opt out and use the carriageway instead. Since already it is a suboptimal solution : the track is away from the carriageway.
SOLUTION	Correction in the slope with gradient from 1:12 - 1:20. No free left turning should be allowed. A landing at +150mm level is preferred near the junction with adequate space for crossing cyclists to wait. Hence the ramp to come down from already elevated cycle track to +150mm level should be set back by 5 to 10m. The use of raised crossing at the location of zebra crossing across the side road was also suggested by ACP traffic.

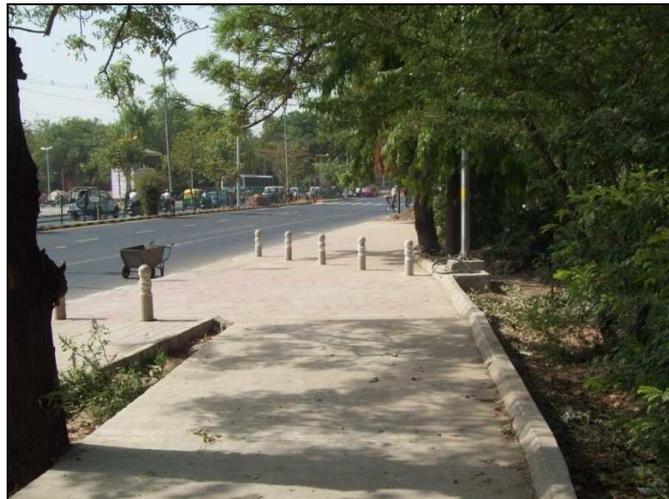
PROBLEM IDENTIFIED	The entry into the cycle track is perpendicular to the travel flow. Raised crossing at 11800 is not constructed, because of objections raised by the resident at this area.
IMPLICATION	Cyclist prefer directness and coherence of a bicycle infrastructure more than anything else. Indirect entrances result in reduced speed , sharp turns and dangerous maneuvers, not preferred by NMV users. They thus miss the entrance and continue straight on the carriageway mixing with buses, raising the risk of fatal accidents.

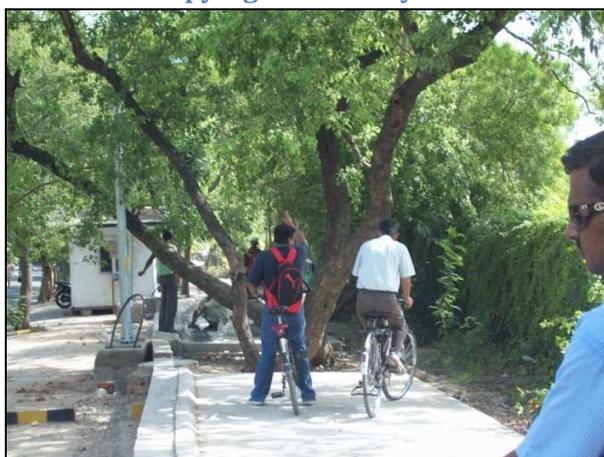
PROBLEM IDENTIFIED	The tree occupies the entire width of the footpath. Also the cycle track is visually hidden from the main carriageway due to this wall between the footpath and the cycle track.
IMPLICATION	Even if the cyclists enter once and use this, they would easily opt out and use the carriageway instead. Since already it is a suboptimal solution : the track is away from the carriageway.
SOLUTION	The cycle track should be taken around the tree and it can be easily done. The wall dividing the track and the footpath should be broken so that the a visible connection is achieved between cyclists and the carriageway (even if it cannot be physically close to it). Use of retro-reflective stickers on trees is important to ensure cyclist safety.
REMARKS	The chances of the cycle track being used look faint because it is at the rear, away from the carriageway. e.

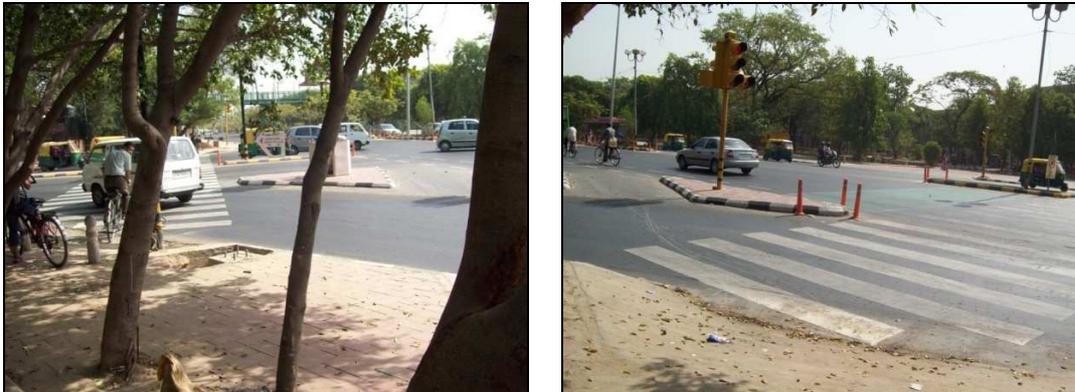
PROBLEM IDENTIFIED	The ramp for the cyclists onto the junction is very steep and there is no space for the pedestrians to stand, let alone cyclists. Constant left turning vehicles make it difficult to cross.
IMPLICATION	Even if the cyclists enter once and use this, they would easily opt out and use the carriageway instead. Since already it is a suboptimal solution : the track is away from the carriageway.
SOLUTION	Raised crossing should be introduced for left turning vehicles. A raised crossing with 80mm interlocking tiles (red color) as used in other parts should be incorporated with gentle ramp for cyclists and steeper ramps for cars. The left turning traffic needs to be stopped using a traffic signal This was also highlighted to ACP, Traffic Police.
REMARKS	The chances of the cycle track being used look faint because it is at the rear, away from the carriageway. A task with operations would be to introduce the facility to the cyclists has to be taken up but any kind of the obstacles should be removed to make it reliable.

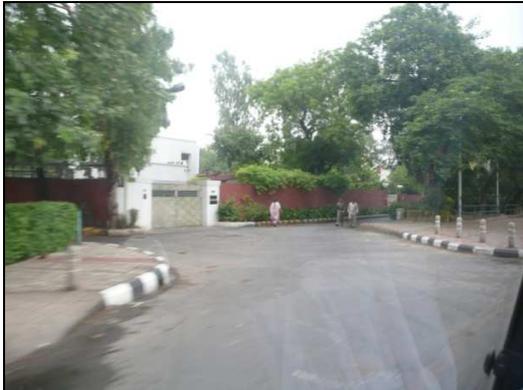
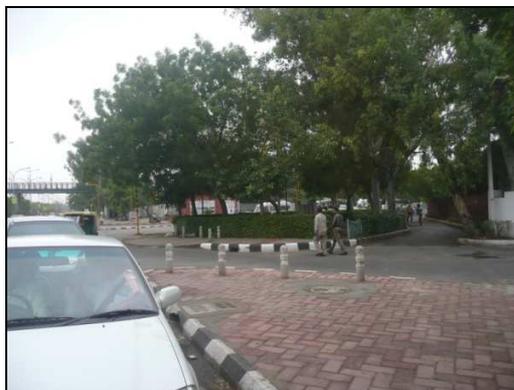
PROBLEM IDENTIFIED	<p>Turning vehicles into the service lane are in conflict with the pedestrians and cyclists. No continuous footpath from the junction before. 1:12 – 1:20 gradient ramps missing. Raised crossing missing. RITES representative informed that they were not able to make a raised crossing due to the non-agreement of the people residing.</p>
IMPLICATION	<p>It would be difficult to get the cyclists into the segregated cycle track made ahead. Especially since it has an in-direct and angular entry (it is not aligned to the cyclists natural path of movement) about 100m ahead of the ones proposed in the drawing.</p>
SOLUTION	<p>Raised crossing with 80mm interlocking tiles (red color) as used in other parts needs to be constructed at chainage 11800, to ensure continuity. Here ACP traffic commented that since vehicle entering the service lane are few, a raised crossing since objected by the resident, may be avoidable. Mr. Gandhi suggested explaining to the resident the safety benefits of raised crossing and informing them that their entrance will not get affected in any adverse way.</p> <p>ACP traffic police also suggested that the left turning traffic at the junction needs to be stopped using a traffic signal. This was also highlighted to ACP, Traffic Police.</p>

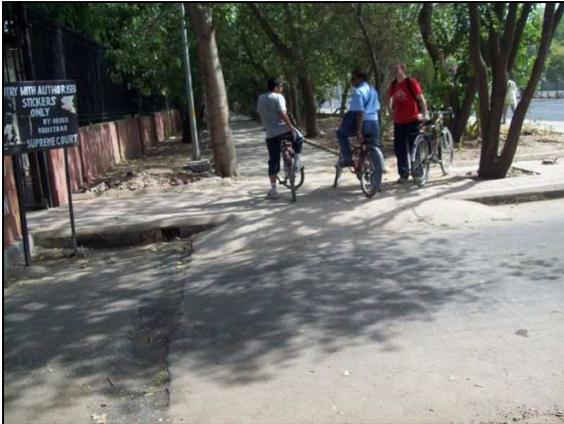
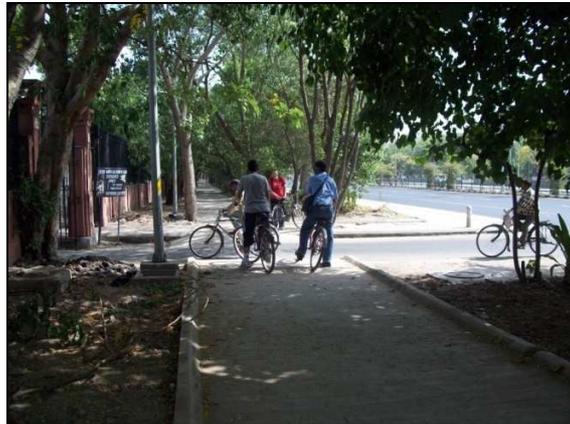
PROBLEM IDENTIFIED	No raised crossing at various supreme court entrances. Turning vehicles enter at a speed and do not slow down for crossing pedestrians and cyclists. Also the ramps provided for pedestrians and cyclists are very steep at the entrances.
IMPLICATION	Raised crossing design makes it unfavorable for bicycle and wheelchair use. Even if the cyclists enter once and use this, they would easily opt out and use the carriageway instead. The facility does not present any signs of providing better directness, coherence and comfort for cyclists (and places like these even safety is compromised), hence giving cyclists no incentive to use the bicycle facility.
SOLUTION	Raised crossing should be introduced for left turning vehicles. A raised crossing with 80mm interlocking tiles (red color) as used in other parts should be incorporated with gentle ramp for cyclists and steeper ramps for cars. The left turning traffic needs to be warned using a blinker.

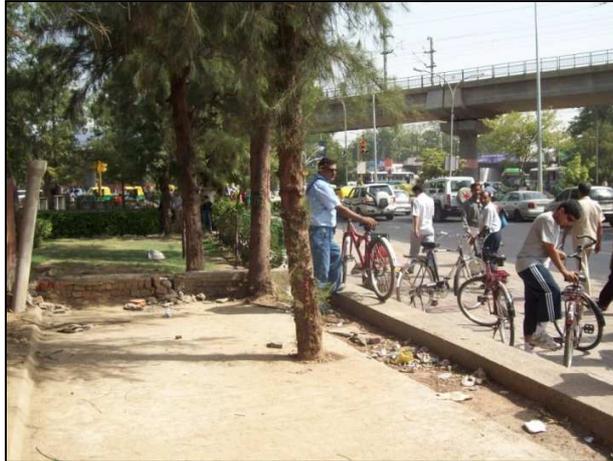
<p>PROBLEM IDENTIFIED</p>	<p>The Cycle track terminates on the wall of the park at tilak bridge junction and no temporary provision of exiting cyclists have been made . Neither any ramp to bring on the footpath. RITES representative informed that the cycle track is through the park and the work is pending. No space for cyclists to stand on the shared pedestrian path before coming on to the junction. Crossing the Tilak Bridge on Cyclists is a very dangerous task. It lacked refuge islands for cyclists.</p>
<p>IMPLICATION</p>	<p>Unfavorable to cycle if not smooth. Even if the cyclists enter once and use this, they would easily opt out and use the carriageway instead. Since already it is a suboptimal solution : the track is away from the carriageway. Crossing the junction is a safety hazard.</p>
<p>SOLUTION</p>	<p>The track should be terminated at the junction (as per junction designs with adequate ramps and waiting spaces for cyclists). Here space needs to be acquired from the park from both pedestrians and cyclists to wait. Since junction crossing should be critically looked into, it was suggested by Ms. Ruchi that on large junctions like these the path of the cyclists should be marked throughout the junction. ACP, Traffic Police was asked by Mr. Bishop, if something could be looked into with the signal cycle. For eg, a separate phase for the cyclists.</p>

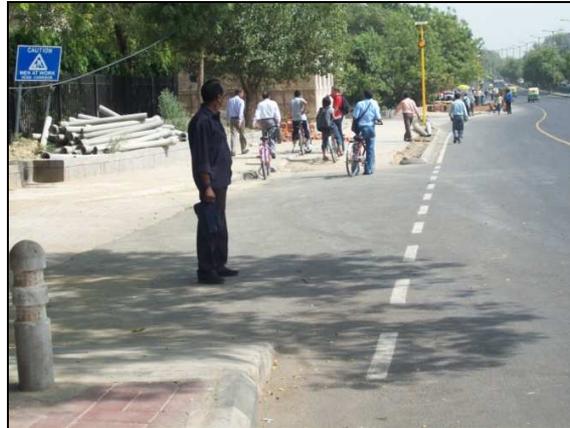
PROBLEM IDENTIFIED	The entry to the cycle track is not in the natural alignment of the path of the cyclists. Raised crossing missing and discontinuous footpath.
IMPLICATION	The cyclists would miss the entry and then be with the carriageway traffic in unsafe conditions.
SOLUTION	The entry needs to be re-looked into and should be along the natural alignment of the cyclists. Here Ruchi informed the auditors that the desired alignment is shown and included in the design drawings provided to RITES.

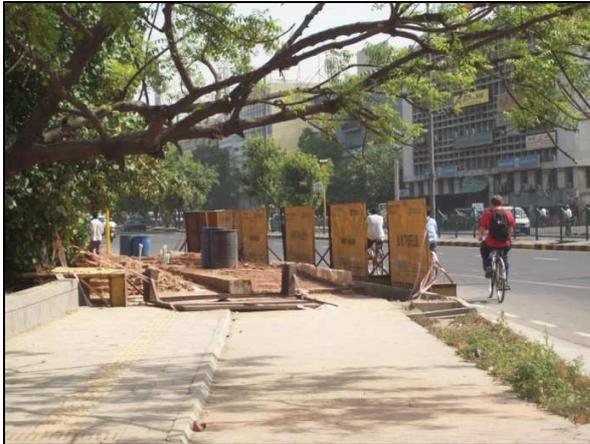
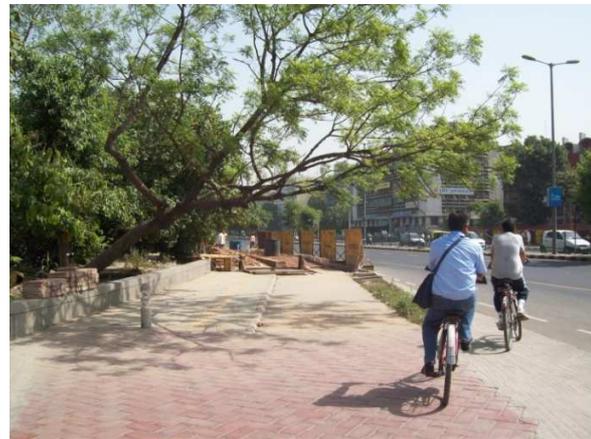
PROBLEM IDENTIFIED	The bus shelter is constructed on the segregated cycle track. Cyclists move on the carriageway.
IMPLICATION	It is a visual obstruction, a clear encroachment of space of cyclists, cyclists move out onto the carriageway and merge with carriageway since a raised crossing and ramp to the carriageway is right next to the shelter.(as seen in the photograph). Safety of cyclists is adversely affected.
SOLUTION	<p>It has been suggested by RITES that a ramp before and after the shelter is constructed with marking for cyclists to use the footpath. Here, since cyclists are expected to deviate from their rightful and natural path, they are likely to choose a more comfortable and direct option. In which case cyclists will most certainly remain on the carriageway than mix with slower pedestrians on the footpath. This will lead to conflicts between buses and cyclists with near fatal results.</p> <p>A bus shelter at a location where it compromises bicycle infrastructure and safety may not be desirable. At such locations a platform for standing commuters may be used for the shelter with a pole marker, or the shelter design itself needs to be modified so as its implementation does not leave bicycle infrastructure useless. Auditors felt that similar strategy needs to be adapted for this location. Here Ruchi informed the auditors that the shelter was not proposed at this location (as per design drawings) and only a waiting area for commuters with a sign post was proposed in the drawing, and the same may be followed to resolve this problem.</p>

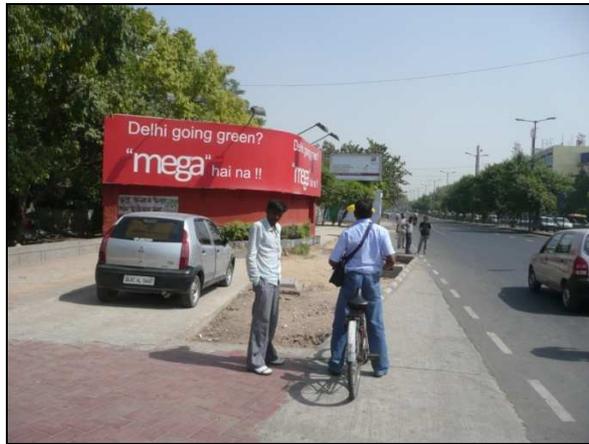
<p>PROBLEM IDENTIFIED</p>	<p>Cycle track is terminated or discontinued due to the presence of an existing dust bin. RITES representative informed that a request with MCD has been sent and DIMTS is following up the same</p>
<p>IMPLICATION</p>	<p>The dead end can be seen from a distance. The cyclists would move out onto the carriageway and mix with the traffic. All such inconveniences requiring cyclists to move on and off the track either to the carriageway or to the footpath, discourage cyclists from using the track even in areas where it is reasonably usable (for short stretches). Cyclists will opt for a continuous direct path which in this case is offered by the carriageway. This though entails the risk if cyclists getting hit by buses or other vehicles (like any other road in Delhi).</p>
<p>SOLUTION</p>	<p>Dust Bin needs to be removed along with any other encroachments in the cycle track to ensure a continuous quality facility.</p>

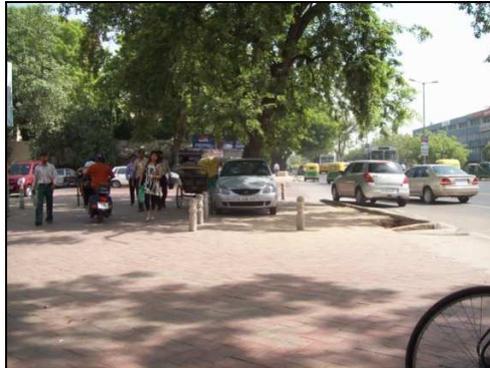
13400 LHS – Illegal Parking on Cycle Track and Footpath

PROBLEM IDENTIFIED	Car parking on the track for cyclists.
IMPLICATION	Cyclists discouraged to use the shared facility and move onto the carriageway.
SOLUTION	Enforcement should be strengthened. The path of the cyclists should be marked on raised / shared areas to inform other users and prevent encroachment.

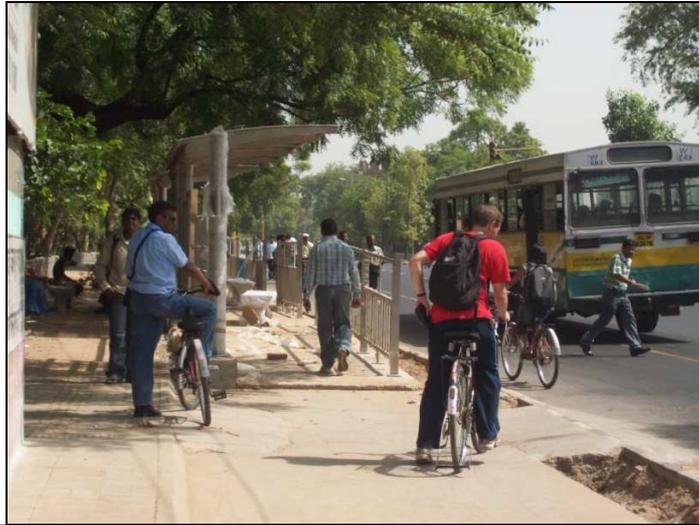
PROBLEM IDENTIFIED	The bus shelter is constructed on the segregated cycle track. Cyclists move on the carriageway.
IMPLICATION	It is a visual obstruction, a clear encroachment of space of cyclists, cyclists move out onto the carriageway and merge with carriageway since a raised crossing and ramp to the carriageway is right next to the shelter. Safety of cyclists is affected.
SOLUTION	The bus shelter should be shifted to its planned location at chainage 13540 (TSR parking) with or without a shelter. However it was suggested by RITES that a ramp before and after the shelter will be constructed with marking for cyclists to use the footpath. It was though agreed by most auditors that, the cyclists won't use the footpath since the entry width is very slim (masjid next to it and cyclists are already sharing the footpath from ITO subway) and filled with trees. They would opt for the carriageway and mainstream cyclists might not even enter the facility from the very beginning.

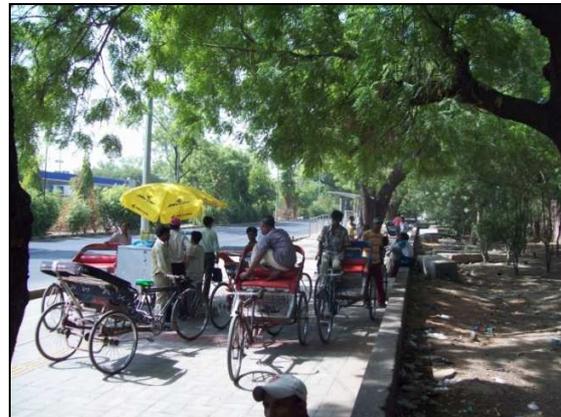
14180 LHS – Bus shelter on Cycle track, Cycle Rickshaws Parked on Footpath

<p>PROBLEM IDENTIFIED</p>	<p>The bus shelter is constructed on the segregated cycle track. Cyclists move on the carriageway. The pedestrian path was occupied by cycle rickshaws acting as feeder to the shelter.</p>
<p>IMPLICATION</p>	<p>It is a visual obstruction, a clear encroachment of space of cyclists, cyclists move out onto the carriageway and merge with carriageway since a raised crossing and ramp to the carriageway is right next to the shelter. Safety of cyclists is affected.</p>
<p>SOLUTION</p>	<p>It has been suggested by RITES that a ramp before and after the shelter is constructed with marking for cyclists to weave with the footpath. Cyclists would move out onto the carriageway and merge with carriageway using the raised crossing 20m before the shelter.</p> <p>Since there is space at the rear of the footpath (well shaded and wide) , a rickshaw parking could be created.</p>
<p>REMARKS</p>	<p>Bus shelter was seen as an encroachment in the cycle track. The Traffic Police also commented on such actions. They saw this as a redundant effort and did not see the reason of why a formal big shelter is required to run left lanes. This could also work by installing a signage indicating a bus to stop since the entire action has been done to experiment the center and the left lane of the BRT.</p>
