**BUS RAPID TRANSIT CORRIDOR (PART 2)
MOOLCHAND TO DELHI GATE JUNCTION**

**BICYCLE INFRASTRUCTURE AND SAFETY
BASED ON CYCLE AUDIT**

CONDUCTED ON 19th June / 26th June / 1st July 2009

DIMTS Ltd.

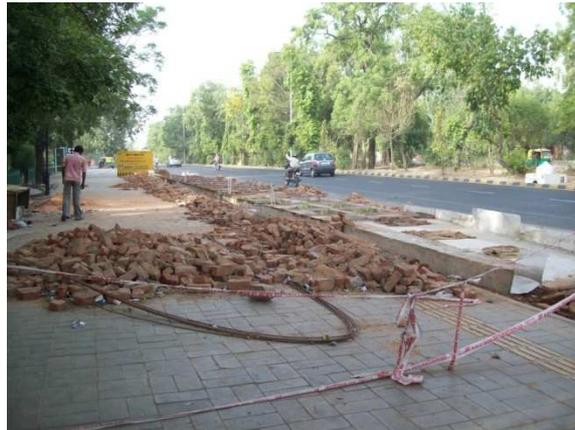
PROBLEM IDENTIFIED	The bus shelter is constructed on the segregated cycle track. Cyclists move on the carriageway.
IMPLICATION	It is a visual obstruction, a clear encroachment of space of cyclists, cyclists move out onto the carriageway and merge with carriageway using the raised crossing at the petrol pump before the shelter Making it unsafe as this gets them to a conflict with the buses.
SOLUTION	The bus shelter (formal structure) is not required here and may be replaced by pole marker and paved area between cycle track and carriageway for commuters to stand (up to 1m width), with raised crossing access across cycle track. Also designs to include or designate hawker spaces may be required so as they do not encroach the bicycle infrastructure.
REMARKS	It was seen as an encroachment in the cycle track. The Traffic Police also commented on such actions. They saw this as a redundant effort and did not see the reason of why a formal big shelter is required to run left lanes. This could also work by installing a signage indicating a bus to stop since the entire action has been done to experiment the center and the left lane of the BRT.

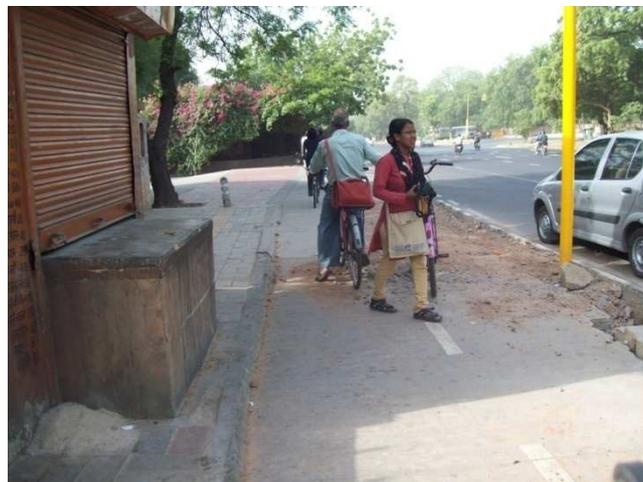
OBSERVATION / PROBLEM IDENTIFIED	Restricted footpath due to an MCD shop.
IMPLICATION	The pedestrians would use the cycle track
SOLUTION	Removal of the shop. RITES informed that MCD was informed for its removal.

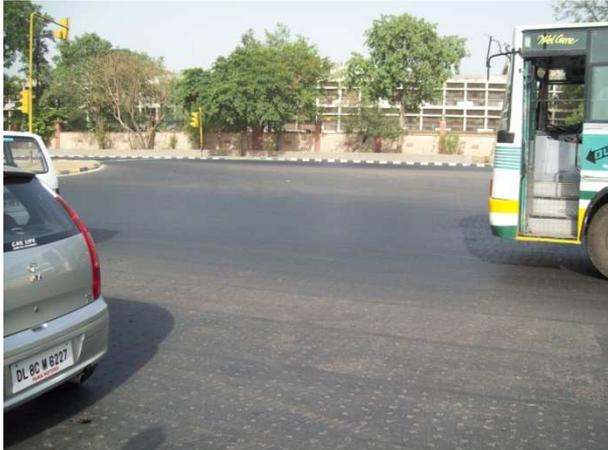
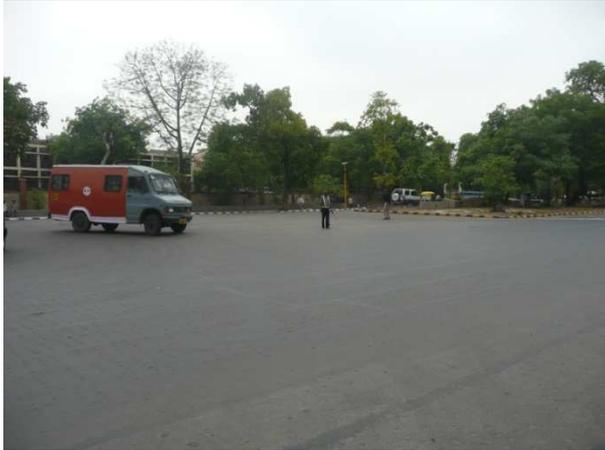
3.2.3 13500 - MAMC junction – Missing Pavement Markings

OBSERVATION / PROBLEM IDENTIFIED	The wide junction did not have any kind of paint marking/signaling not working. Marshall seen managing traffic in unsafe conditions.
IMPLICATION	Concern for Safety
SOLUTION	RITES representative informed that the painting work is pending and would be taken up. A police box (umbrella) can be placed on a refuge space within the intersection for safety of marshall or any policeman managing traffic.
REMARKS	ACP Traffic gave his consent and said it was a practical option , if space permits.

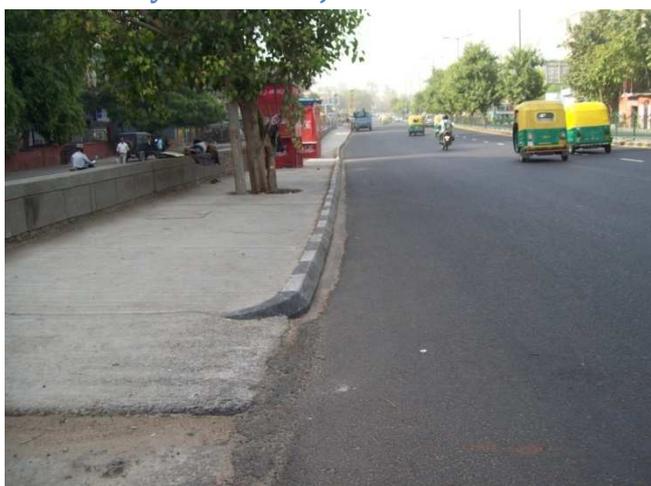
OBSERVATION / PROBLEM IDENTIFIED	Lack of ROW on the BSZ marg. No space for segregation, therefore painted bicycle lane.
IMPLICATION	Cyclist mix with fast motorized traffic without any segregation creating risk of fatal accidents.
SOLUTION	The main stream cyclists would opt for the elevated roadway on BSZ Marg. Hence segregation needs to be provided at the upper level. In case a physical kerb segregation with bare minimum 2.0m wide cycle track is not possible, traffic calming measures to reduce vehicular speeds should be provided. In addition bicycle infrastructure should be provided in the service lane. This requires provision of signages and speed reduction using traffic calming measures.
REMARKS	Use of the lower service lane through media houses can be used as an alternative. Although once the peak hour starts and the lane is occupied by parked vehicles, it becomes unfavorable for use by cyclists.

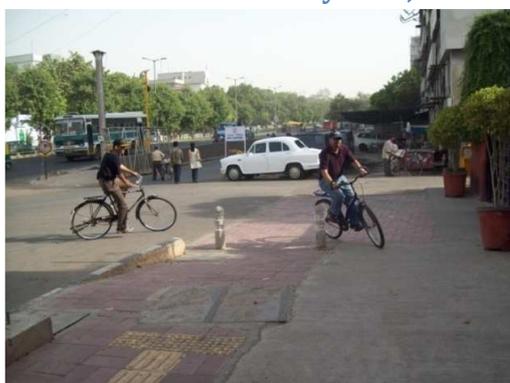
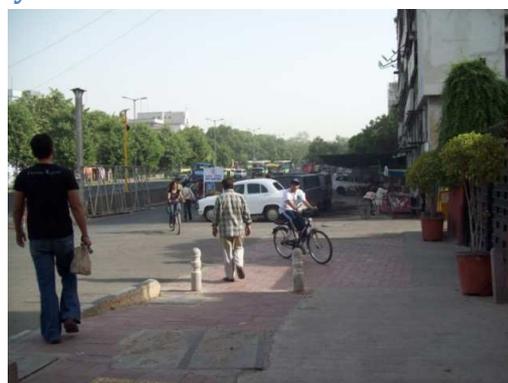
3.2.5 13250 RHS - Disconnected Bicycle Infrastructure - Cycle Track Pushed Next to Boundary Wall, Encroached by Pedestrians

<p>OBSERVATION / PROBLEM IDENTIFIED</p>	<p>The cycle track has been constructed at the rear – along the boundary wall. A compromise in the slope of the ramp can be clearly seen. It is very steep. No raised crossings have been provided for cyclists to cross service lane and access cycle track.</p> <p>Cycle track at the rear (near Gandhi Memorial Hall) is disconnected from the cycle lane proposed on the carriageway, and is thus unlikely to be used.</p>
<p>IMPLICATION</p>	<p>A cyclists won't take such a major detour from the BSZ Marg since it does not come on the natural path of the cyclists and also cannot be seen (or is visually disconnected). Also the cyclists has to cross vehicles exiting from the service lane and get into the cycle track which is a major conflict area since there is no raised crossing to weave in. Clearly accessing cycle track creates near fatal conflicting situation for cyclists.</p> <p>It was also observed that since the location of the cycle track next to Gandhi Memorial Hall was more suitable as a footpath, it was completely occupied by pedestrians. This facility is thus not likely to be used forcing cyclists to mix with buses accessing bus shelters. This creates near fatal conditions for cyclists.</p>

<p>SOLUTION</p>	<p>A raised crossing at service lane crossing with 80mm interlocking tiles (red color) as used in other parts should be incorporated with gentle ramp for cyclists and steeper ramps for cars.</p> <p>It was proposed by Mr. Gandhi that the the near perpendicular detour which is likely to discourage bicycle use can be improved by reducing the bus bay width from 10.5m to 3.3m. This wide space is redundant as buses cannot access bus shelters to come close to the structures for level boarding. The recovered space can be used to provide bus shelters and a segregated cycle track behind them and a wide footpath between the cycle track and the boundary wall.</p> <p>This will make the connection between bicycle facilities more direct with bends no sharper than 30m radius, increasing its chances of use and thus contributing in reducing cyclist fatalities.</p>
<p>REMARKS</p>	<p>The area needs to be critically looked into since it poses high degree safety hazard for the users.</p> <p>Traffic Police agreed that such wide bus bay is redundant for buses.</p>

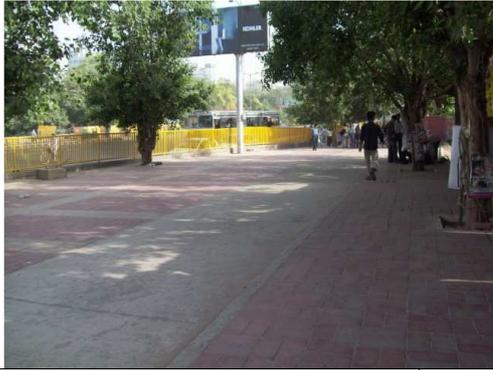
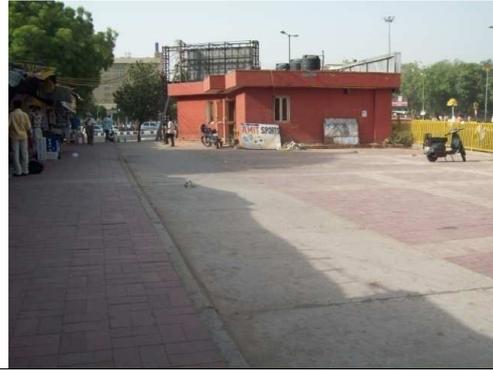
3.2.6 13100 RHS- Cycle Track Away from Carriageway – Mixes with Footpath

OBSERVATION / PROBLEM IDENTIFIED	Cycle track runs through the footpath on either side. No level difference.
IMPLICATION	Unfavorable for cyclists to use the facility, cyclists are likely to mix with motorized vehicles on the carriageway.
SOLUTION	Bicycle track needs to be provided ahead of the BOT toilet, which may need to be re-located if space is a constraint. This will also solve the problem of blind crossing for cyclists at the ITO junction. Ruchi informed the auditors that this is also included in the design drawings, and the same is not currently followed at site.

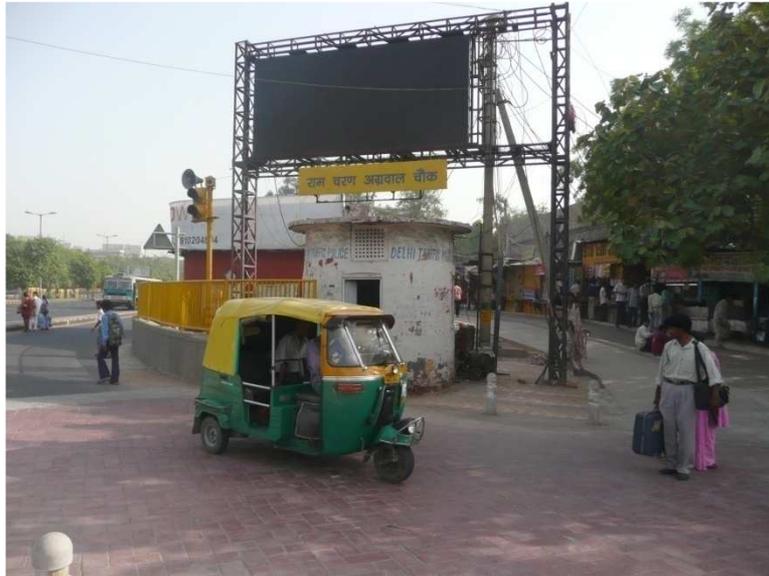
OBSERVATION / PROBLEM IDENTIFIED	Police box completely obscures sight lines for cyclists and pedestrians crossing the road
IMPLICATION	Cyclists would face a collision with motorists taking a left turn, due to a delhi traffic police room, coming in the line of sight.
SOLUTION	As proposed in the previous point, cyclists should be closer to the carriageway which may possibly require shifting of the BOT toilet. In case the same is not possible, railings and the traffic police booth may need to be removed to restore the line of sight.

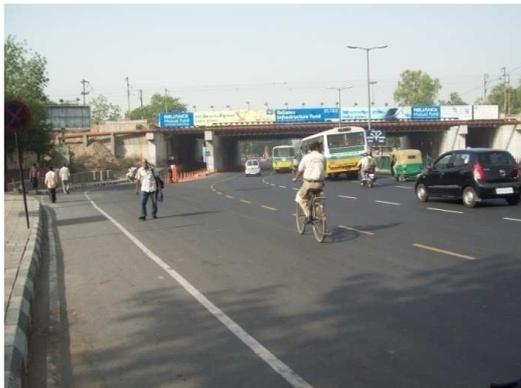
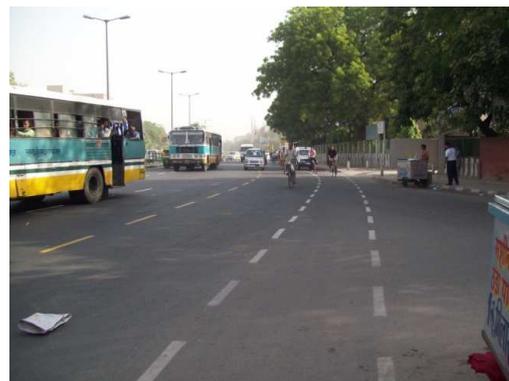
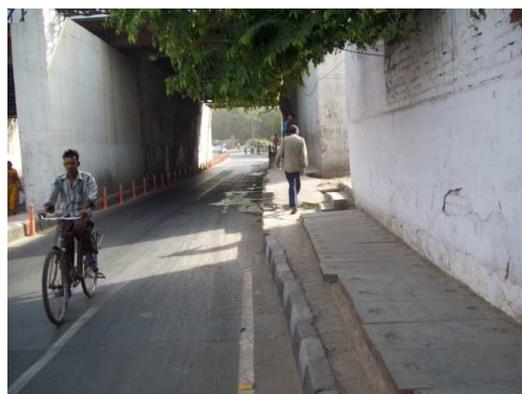
3.2.8 13000 - 12600 - Painted Cycle Lane, Next to Bus Lanes

OBSERVATION / PROBLEM IDENTIFIED	Painted bicycle lane from ITO junction towards Tilak Bridge junction. Cars occupy the side lane for parking / stopping standing.
IMPLICATION	The cyclists overtake the parked vehicles from their right and will have to weave into the bus lane increasing their concern for safety. Painted lanes do not provide safety to cyclists who ride adjacent to high speed buses in the bus lanes. The risk of losing balance and falling in front of moving buses is very high.
SOLUTION	<p>Mr. Gandhi informed the auditors that the proposal for segregated cycle track provided at this location in the design drawings has so far not been developed. He commented that the same may now be followed to develop segregated bicycle infrastructure.</p> <p>ACP traffic police said that an unsegregated bicycle track next to buses is unacceptable and poses grave risk to the life of cyclists. He stressed on the need to segregate cyclists at this locations and at all bus shelters on this stretch. He agreed that we can revert back to segregated cycle track design for this locations and the space for the same looks adequate especially if we include the space allocated to painted bicycle lane.</p> <p>In case segregated cycle tracks as per standard design and minimum 2.0m clear width, are not possible to construct using standard design and hard, 75cm wide median, traffic calming measures are required to reduce vehicular speed on the carriageway to 30km/hr.</p>

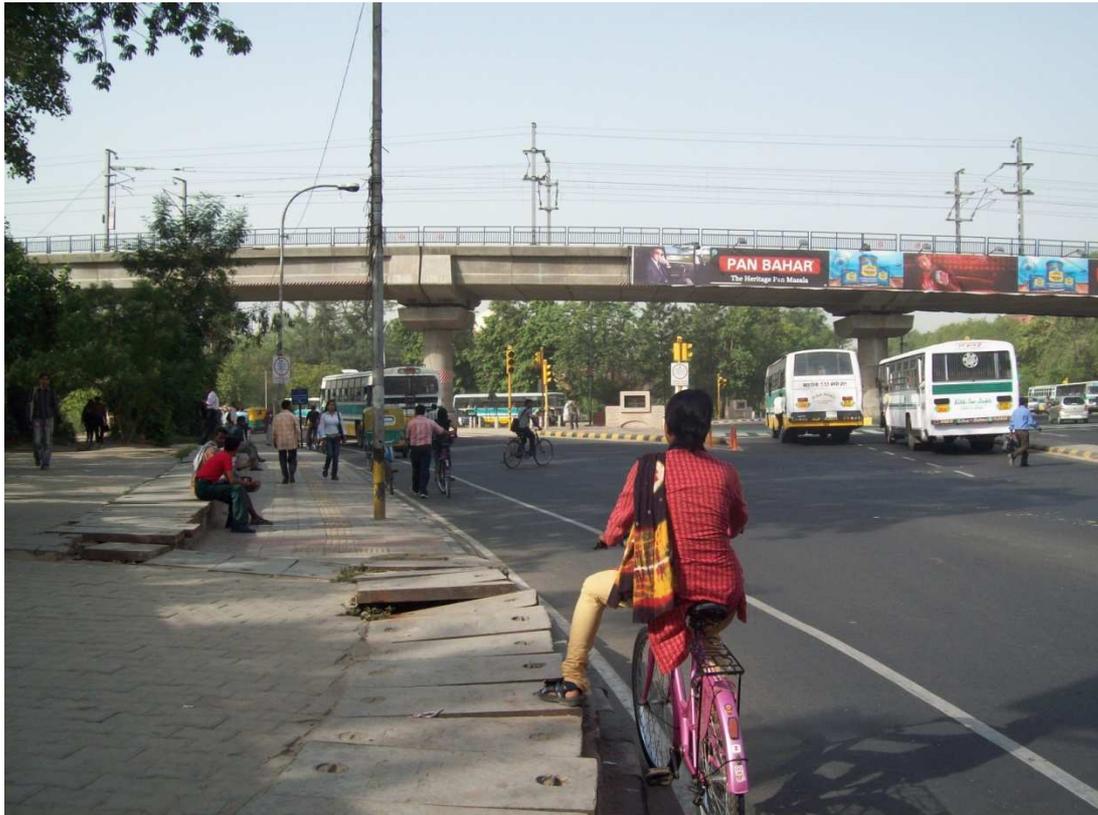
OBSERVATION / PROBLEM IDENTIFIED	There is no raised area for crossing bicyclists at the intersection. The painted bicycle lane is next to a high footpath.
IMPLICATION	Conflict with high speed left turning vehicles. This reduces the effective width of the painted lane. Safety hazard for bicyclists.
SOLUTION	Raised crossing in red colour 80mm thick cement concrete tiles as per standard raised crossing design with 1:8 to 1:10 ramp for motor vehicles, should be provided at this and all other free turning locations. Ruchi explained that the layout designs and the details drawings for the same exist with Rites and the same can be followed without any problem at this location.

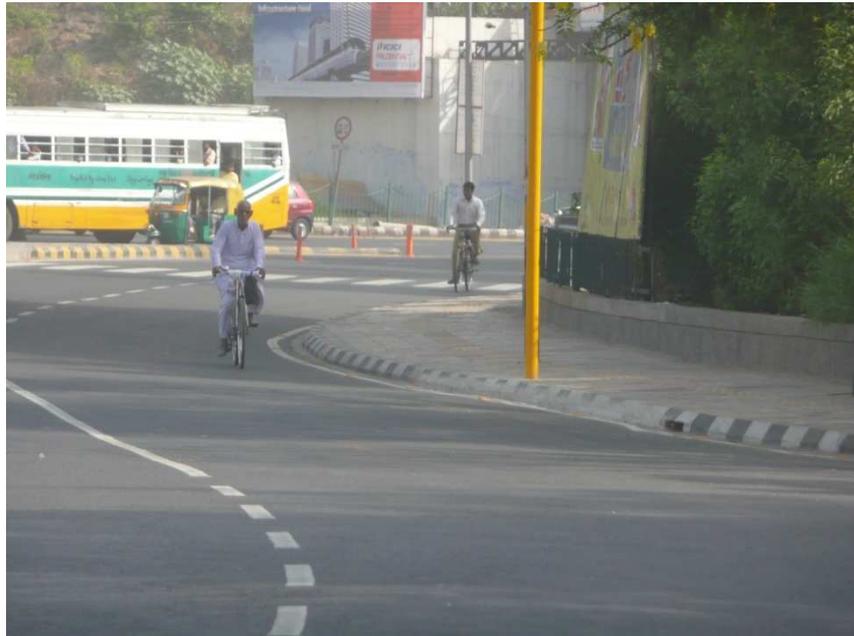
OBSERVATION / PROBLEM IDENTIFIED	No raised crossing at free left turns at Tilak Bridge crossing
IMPLICATION	Unsafe for cyclists, vehicles do not slow down. They mix with the left turning traffic and are in conflict with the straight coming traffic.
SOLUTION	Raised crossing should be provided as per standard details in 80mm thick red colour cement tiles. Sandeep Informed that the drawing for the same already exists with RITES.

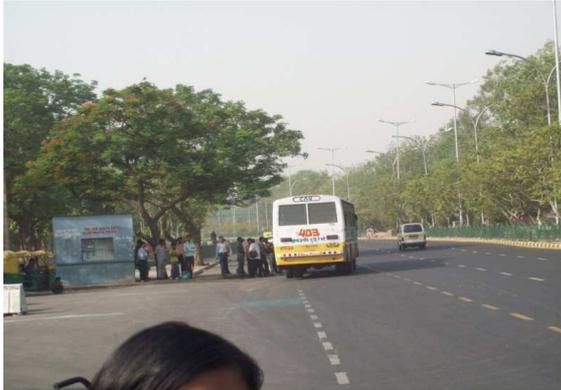
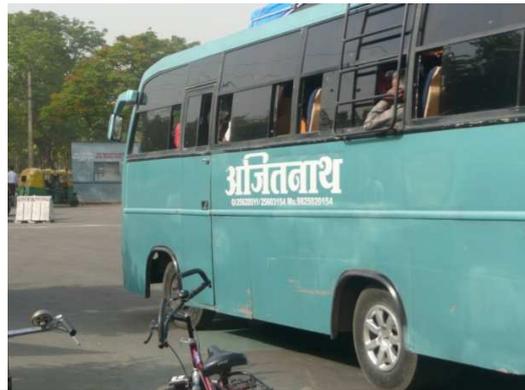
12420 RHS – Bus Commuters Wait on the Cycle Lane

OBSERVATION / PROBLEM IDENTIFIED	Cycle lane occupied by waiting bus commuters. Bus lane along painted cycle lane.
IMPLICATION	The cyclists would either overtake from the right most lane i.e. mix with oncoming fast traffic in the car lanes.
SOLUTION	Segregated cycle track needs to be provided at this location along with adequate footpath and hawker spaces. At designated bus shelters the track should gently maneuver behind the shelter, staying as close to the carriageway as possible. Sandeep informed all that drawings for the same are available. ACP traffic agreed that we should revert to the segregated cycle track designs. In case segregated cycle tracks as per standard design and minimum 2.0m clear width, are not possible to construct using standard design and hard, 75cm wide median, traffic calming measures are required to reduce vehicular speed on the carriageway to 30km/hr.

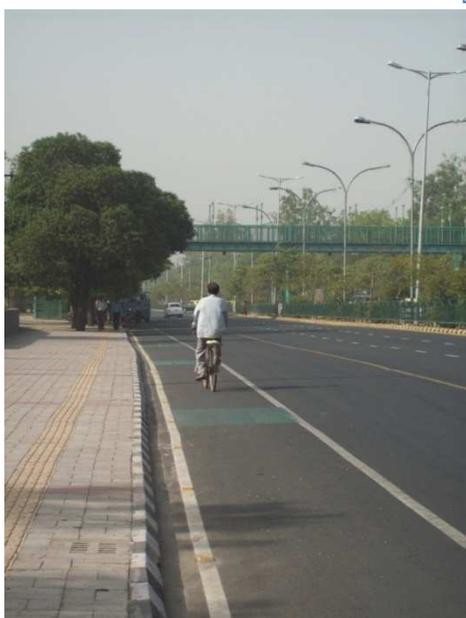
<p>OBSERVATION / PROBLEM IDENTIFIED</p>	<p>Painted cycle lane next to bus lane.</p>
<p>IMPLICATION</p>	<p>Conflict with high speed bus and slow moving NMT.</p>
<p>SOLUTION</p>	<p>Mr. Gandhi informed the auditors that the proposal for segregated cycle track provided at this location in the design drawings has so far not been developed. He commented that the same may now be followed to develop segregated bicycle infrastructure.</p> <p>ACP traffic police said that an unsegregated bicycle track next to buses is unacceptable and poses grave risk to the life of cyclists. He stressed on the need to segregate cyclists at this locations and at all bus shelters on this stretch. He agreed that we can revert back to segregated cycle track design for this locations and the space for the same looks adequate especially if we include the space allocated to painted bicycle lane.</p> <p>In case segregated cycle tracks as per standard design and minimum 2.0m clear width, are not possible to construct using standard design and hard, 75cm wide median, traffic calming measures are required to reduce vehicular speed on the carriageway to 30km/hr.</p>

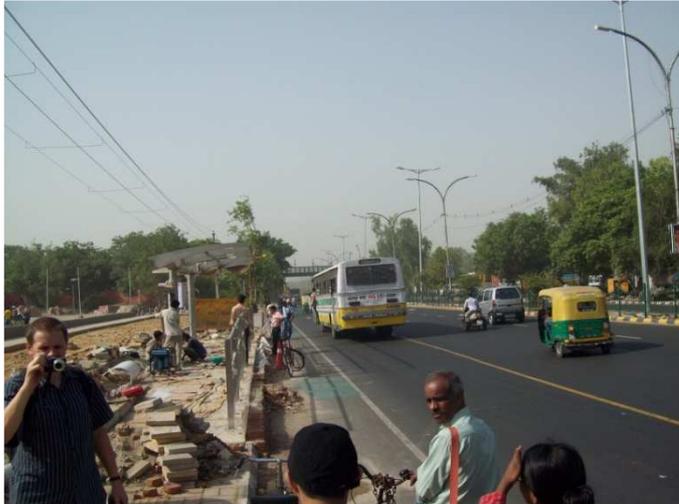
<p>OBSERVATION / PROBLEM IDENTIFIED</p>	<p>Bus shelter and painted bicycle lane brings buses right up alongside cyclists, precisely what the central lane operations of the original BRT prevented</p>
<p>IMPLICATION</p>	<p>Safety concern for cyclists. Stopping buses will affect the painted bicycle lane. They would overtake from the right which is a conflict with the car lanes.</p>
<p>SOLUTION</p>	<p>ACP traffic police said that an unsegregated bicycle track next to bus shelters is unacceptable and that it will be impossible for buses to come close to the shelters and passengers will occupy the cycle lane. This will force cyclists on to the bus lane, leading to serious risk of accidents. poses grave risk to the life of cyclists. He stressed on the need to segregate cyclists at this locations, going behind the bus shelter.</p> <p>It was agreed by all auditors that segregated cycle track design for this entire stretch should continue behind the bus shelter, though it should be a very gentle bend so as the cyclists do not have to slow down and the connection appears direct.</p> <p>In case segregated cycle tracks as per standard design and minimum 2.0m clear width, are not possible to construct using standard design and hard, 75cm wide median, traffic calming measures are required to reduce vehicular speed on the carriageway to 30km/hr.</p>

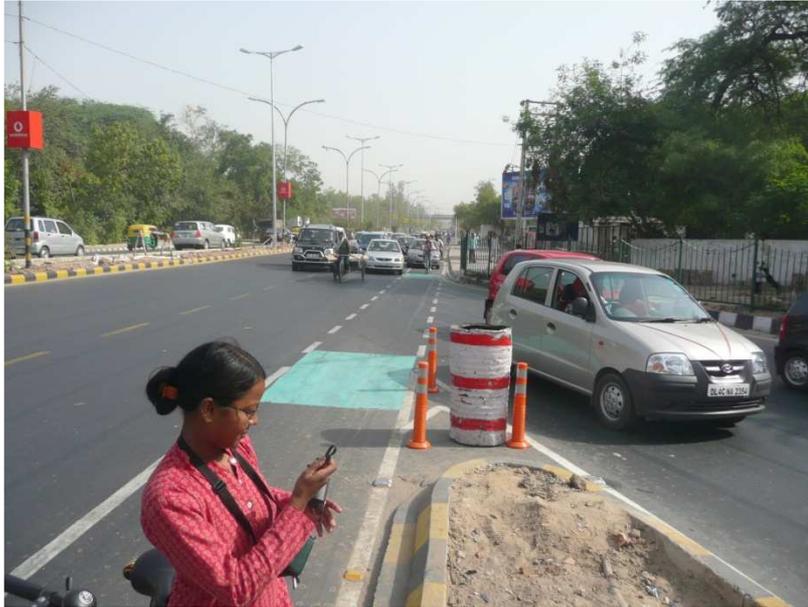
11230 RHS – No Riased Crossing – Unsafe for Crossing Cyclists

<p>OBSERVATION / PROBLEM IDENTIFIED</p>	<p>Painted bicycle lane. No raised crossing to slow down left turning vehicles. No vehicles stop and give way to straight going cyclists.</p>
<p>IMPLICATION</p>	<p>Cycle lanes cut across high speed left turning traffic, and cyclists are not in visual contact of turning vehicles. This is a potentially fatal condition for cycling, and may lead to accidents and loss of life.</p>
<p>SOLUTION</p>	<p>Segregated cycle tracks (as proposed in previous points) should lead directly to raised crossing as per designs followed in BRT-1, which should lead to cycle box on the junction.</p> <p>Ruchi explained that such designs exist and have been submitted to all concerned, thus the same may be used without major interventions at site.</p> <p>It was also discussed that even for some reason segregation is not achieved for cycle track in front of Pragati Maidan, cycle track at least 50 to 100m before Bhairon Marg left turn should be segregated as per standard design to ensure safe bicyclist access to raised crossing which should also be constructed as per standard details in 80mm thick CC tiles in red colour with 1:8 to 1:10 CC ramp for cars.</p> <p>Here Mr. Jain explained that the raised crossing has been constructed in Bitumen. To this Simon and ACP traffic police commented that it is not serving the purpose and vehicles are not being warned and not slowing down. To this Sandeep added that standard raised crossing design in CC tile should be used and detail drawings for the same are available with Rites.</p>

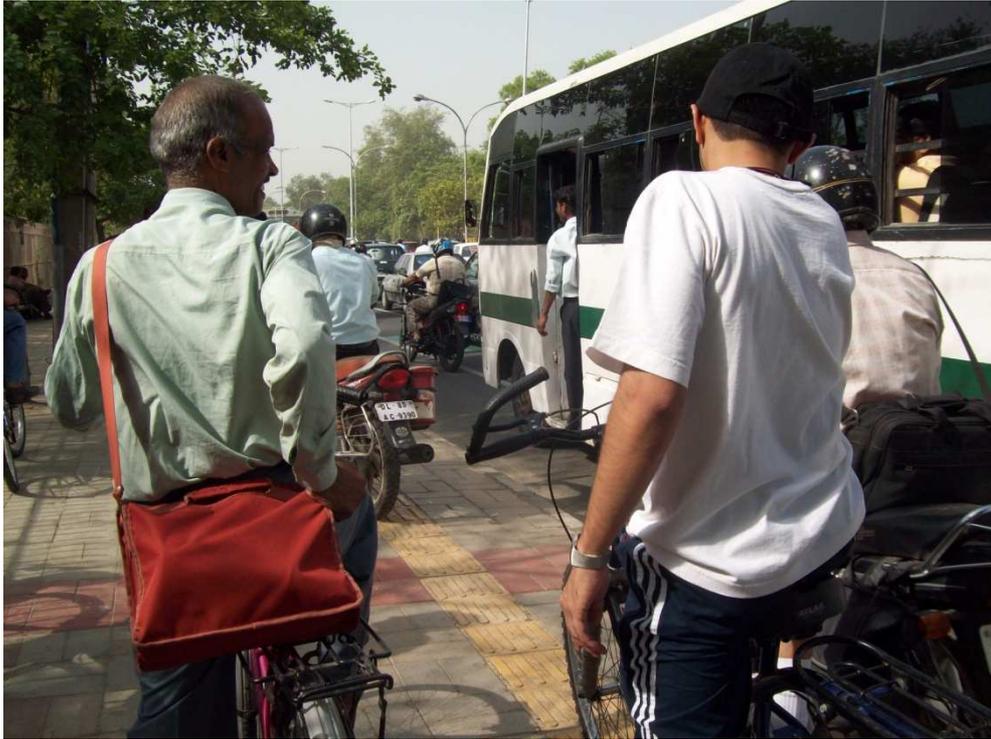
<p>OBSERVATION / PROBLEM IDENTIFIED</p>	<p>Cyclists on footpath with two wheelers. Painted cycle lane occupied by other vehicles.</p>
<p>IMPLICATION</p>	<p>Impossible for cyclists to use the cycle lane due to heavy traffic occupying the lanes for movement and for waiting at the red light. This forces cyclists on to the footpath which is also occupied by two wheelers during peak hour. This creates risky conditions for cyclists even on the footpath.</p>
<p>SOLUTION</p>	<p>Segregated cycle tracks need to be provided for cyclists at this location. This will need effective enforcement to prevent encroachment by two wheelers. It was observed at site and adequate space was available to construct segregated tracks especially if the 1.5m wide painted cycle lane is included. Sandeep informed the auditors that it is possible to construct a segregated track here, as the same is shown on the proposed drawings, which confirms the availability of space. He added that Rites simply has to follow these drawings available with them to improve cyclist infrastructure at this location. In case segregated cycle tracks as per standard design and minimum 2.0m clear width, are not possible to construct using standard design and hard, 75cm wide median, traffic calming measures are required to reduce vehicular speed on the carriageway to 30km/hr.</p>

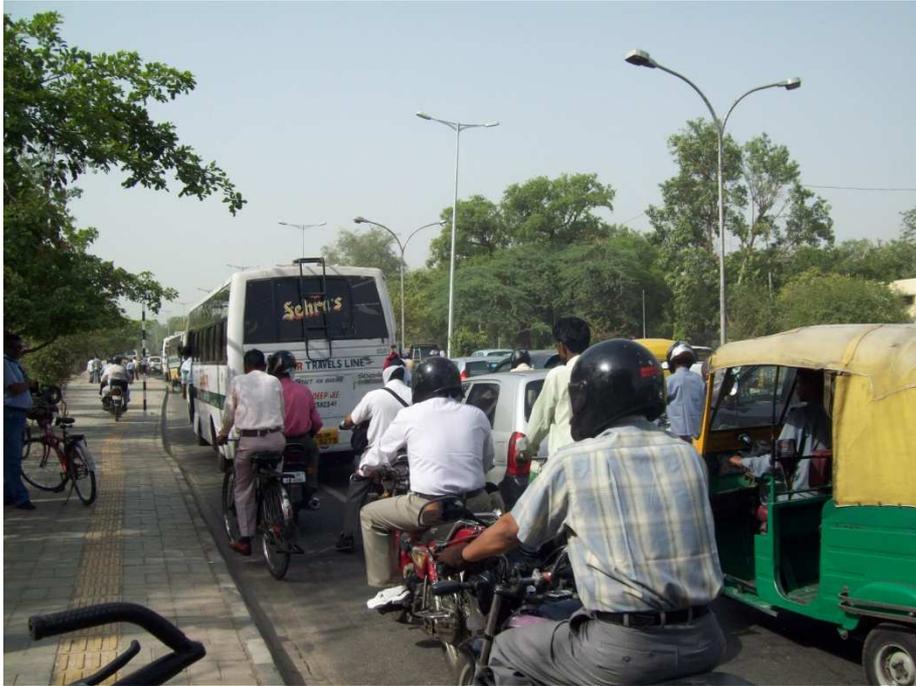
<p>OBSERVATION / PROBLEM IDENTIFIED</p>	<p>Painted cycle lane occupied by other vehicles and buses.</p>
<p>IMPLICATION</p>	<p>Most cyclists are forced onto the footpath with pedestrians(also being used by two-wheelers) and some risk using the carriageway. This creates potentially fatal conditions for cyclists.</p>
<p>SOLUTION</p>	<p>Segregated cycle tracks need to be provided for cyclists at this location. This will need effective enforcement to prevent encroachment by two wheelers. It was observed at site and adequate space was available to construct segregated tracks especially if the 1.5m wide painted cycle lane is included. Sandeep informed the auditors that it is possible to construct a segregated track here, as the same is shown on the proposed drawings, which confirms the availability of space. He added that Rites simply has to follow these drawings available with them to improve cyclist infrastructure at this location. In case segregated cycle tracks as per standard design and minimum 2.0m clear width, are not possible to construct using standard design and hard, 75cm wide median, traffic calming measures are required to reduce vehicular speed on the carriageway to 30km/hr.</p>

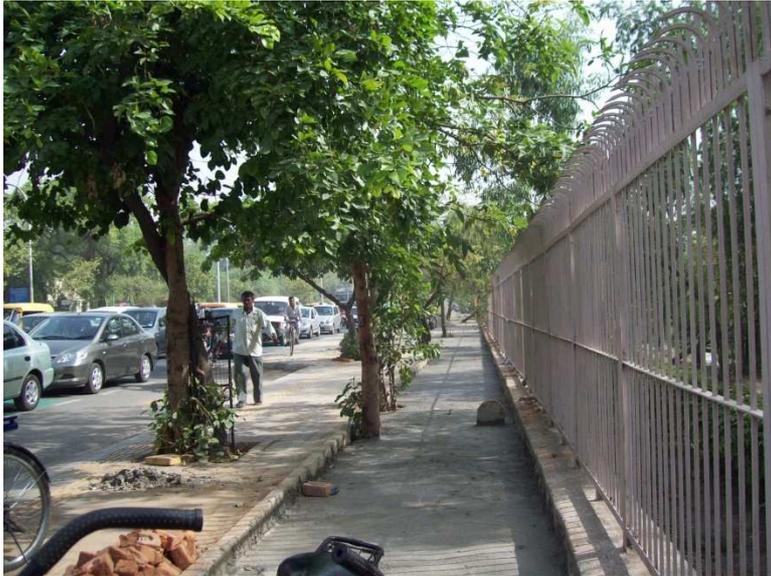
<p>OBSERVATION / PROBLEM IDENTIFIED</p>	<p>Painted cycle lane occupied by other vehicles and buses.</p>
<p>IMPLICATION</p>	<p>Available space for a cycle track, though the same not constructed, forcing cyclists to mix with vehicles in high risk conditions.</p>
<p>SOLUTION</p>	<p>Segregated cycle tracks need to be provided for cyclists at this location. This will need effective enforcement to prevent encroachment by two wheelers. It was observed at site and adequate space was available to construct segregated tracks especially if the 1.5m wide painted cycle lane is included. Sandeep informed the auditors that it is possible to construct a segregated track here, as the same is shown on the proposed drawings, which confirms the availability of space. He added that Rites simply has to follow these drawings available with them to improve cyclist infrastructure at this location. In case segregated cycle tracks are not possible to construct using standard design and hard, 75cm wide median, traffic calming measures are required to reduce vehicular speed on the carriageway to 30km/hr.</p>

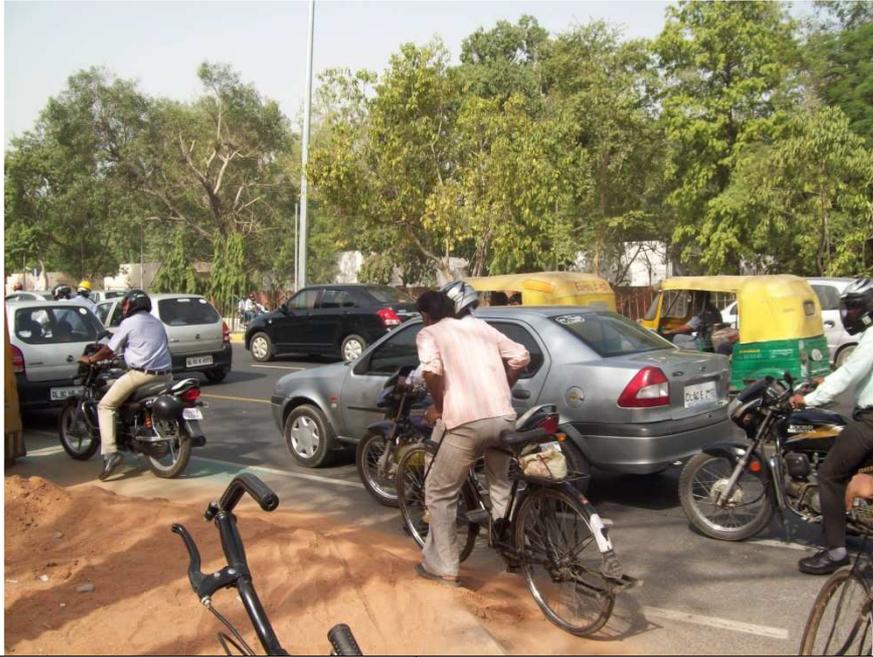
<p>OBSERVATION / PROBLEM IDENTIFIED</p>	<p>Construction debris on cycle lane.</p>
<p>IMPLICATION</p>	<p>Cyclists weave with the bus and car traffic in unsafe conditions. No safe detour demarcated for cyclists.</p>
<p>SOLUTION</p>	<p>Presence of construction debris on the cycle lane was identified as a temporary problem. Though it highlighted the need to create safe detours for cyclists in such conditions. Also it was highlighted that eventually this location should have a segregated cycle track as per standard design. In case segregated cycle tracks are not possible to construct using standard design and hard, 75cm wide median, traffic calming measures are required to reduce vehicular speed on the carriageway to 30km/hr.</p>

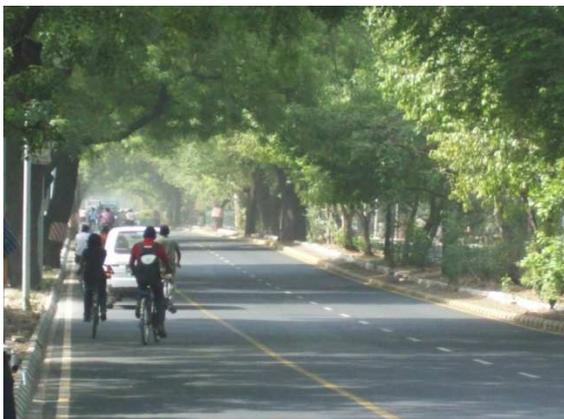
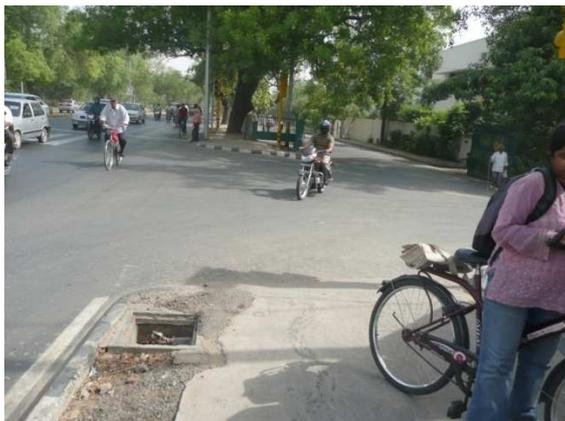
OBSERVATION / PROBLEM IDENTIFIED	Bicycles in mixed traffic conditions. No painted lane for cyclists – lack of ROW. No Raised crossings to slow down traffic.
IMPLICATION	Cyclists share the bus lane, and cross high vehicular traffic without a raised crossing, creating a potential hazardous condition, and increasing risk to their safety.
SOLUTION	<p>In ideal condition a segregated cycle track is preferred for this stretch. However it may not be possible to construct the same due to constrained carriageway (8.5m total) at this location. It is thus desirable to use traffic calming measures to reduce vehicular speed to 30km/hr. or lower.</p> <p>At Sunder Nagar exit points raised crossings need to be provided as per standard design with 80mm thick cement concrete tiles in red colour and CC ramp in 1:8 to 1:10 slope for cars.</p> <p>ACP traffic police also felt the need to carefully think about a solution to ensure cyclist safety at this location. He suggested that the use of service lane by constructing formal bicycle infrastructure may be explored.</p> <p>Ruchi added here that the designs for raised crossing at this location are included in the design drawings available with Rites and the same may be followed.</p>

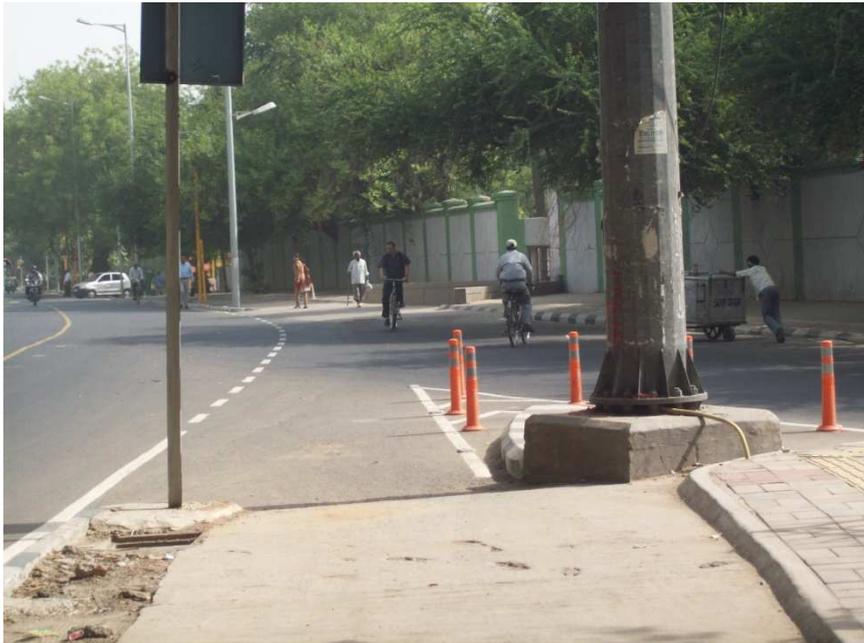
<p>OBSERVATION / PROBLEM IDENTIFIED</p>	<p>Absence of the raised crossing.</p>
<p>IMPLICATION</p>	<p>Crossing cyclists in conflict with left turning car traffic, raise concerns for their safety.</p>
<p>SOLUTION</p>	<p>Raised crossing needs to be provided as per standard design with 80mm thick cement concrete tiles in red colour and CC ramp in 1:8 to 1:10 slope for cars. Ruchi added here that the designs for raised crossing at this location are included in the design drawings available with Rites and the same may be followed.</p>

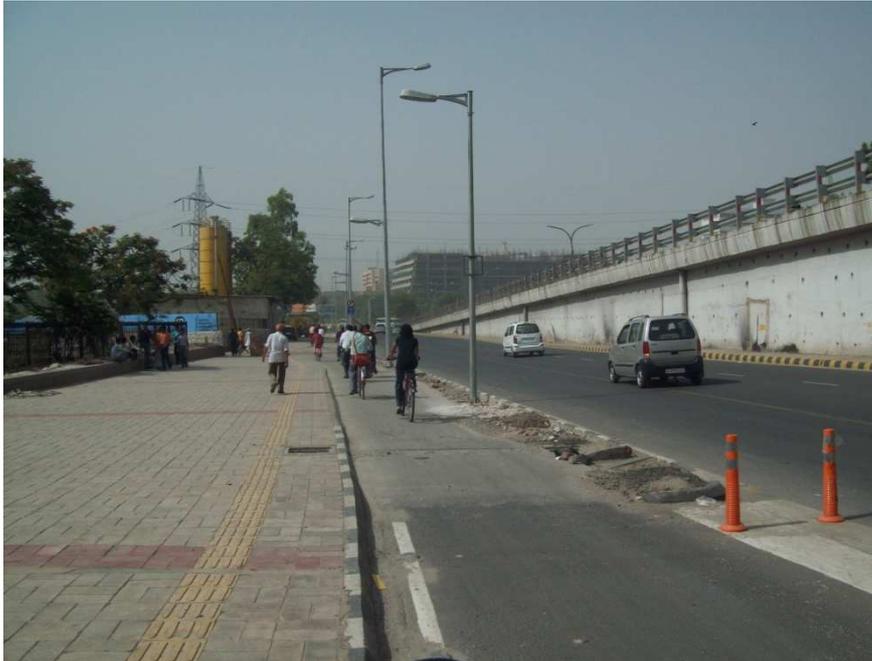
OBSERVATION / PROBLEM IDENTIFIED	Signage indicating 'Cycle Track' is missing. Open pits and construction debris lying in unpaved area.
IMPLICATION	Cyclists may miss the cycle track entrance and mix with motorized vehicles on the carriageway. Debris on the track also serves to discourage its use,
SOLUTION	Install adequate signage as per standard design and clear the track of construction debris.
REMARKS	The gradient of the slope at the entry to cycle track does not comply with 1:12 to 1:20 slope.

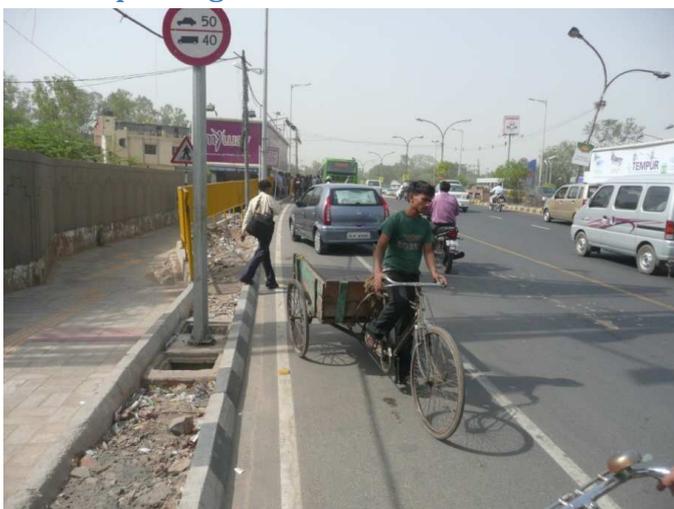
OBSERVATION / PROBLEM IDENTIFIED	Painted bicycle lane. Cars occupy the side lane for parking / stopping standing.
---	--

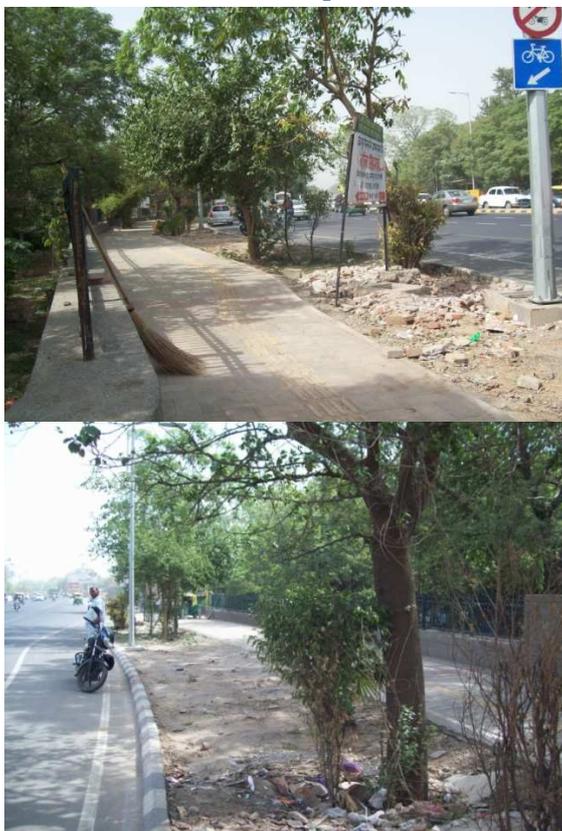
<p>OBSERVATION / PROBLEM IDENTIFIED</p>	<p>No cycle track present at the location 'cycle track' signboard has been used. Ruchi informed the auditors that the footpath has been constructed on the proposed cycle track alignments. The footpath is to be provided from the park which is acquired, as shown in proposed drawings submitted to Rites. Mr. Jain informed the auditors that cycle track will be constructed, as soon permission to cut the trees is received. Ruchi commented on this that if drawings are followed the cycle track and footpath can be achieved without cutting additional trees.</p>
<p>IMPLICATION</p>	<p>Cyclists use the carriageway even when space exists to construct a perfectly good cycle track to maintain continuity after CGO subway.</p>
<p>SOLUTION</p>	<p>Enough space to construct a track. Also there is a nala before where a segregated cycle track can be constructed. This will in turn give a 200m length of segregated facility for the cyclists.</p>

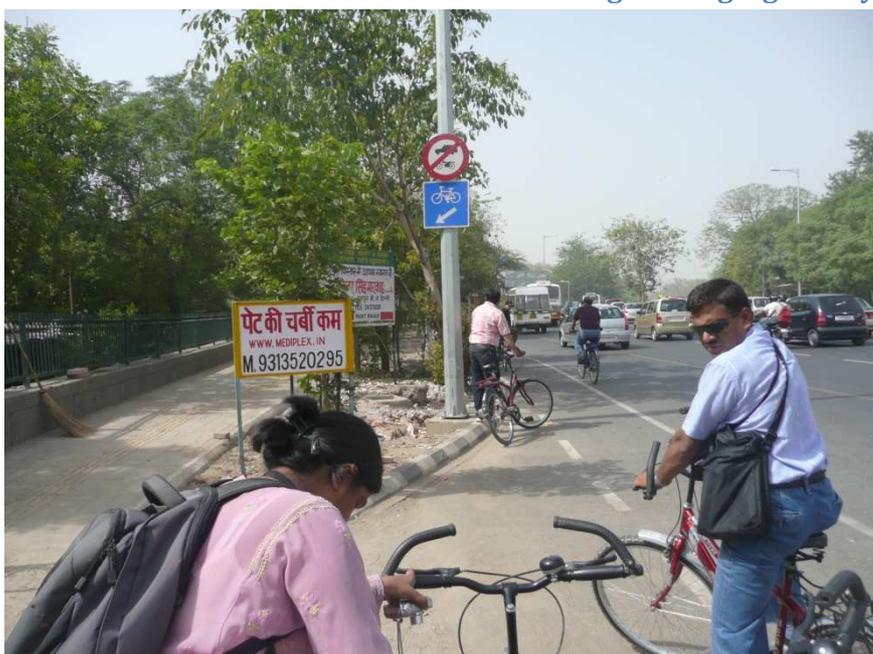
<p>OBSERVATION / PROBLEM IDENTIFIED</p>	<p>Un-constructed raised crossing to enter the segregated facility (also missing on site).</p>
<p>IMPLICATION</p>	<p>Cyclists use the carriageway, and are at risk of being hit by turning vehicles.</p>
<p>SOLUTION</p>	<p>All auditors agreed that raised crossing as per standard design in 80mm thick red colour CC tiles was an essential requirement for the bicycle infrastructure and can easily be constructed at all free turning locations including this one. Sandeep added that the design of a raised crossing is included in the drawings for this location already available with Rites. If the same is followed along with other solutions of developing segregated tracks ahead and behind (see points above) then a safe and usable facility can be developed with higher chances of used.</p>

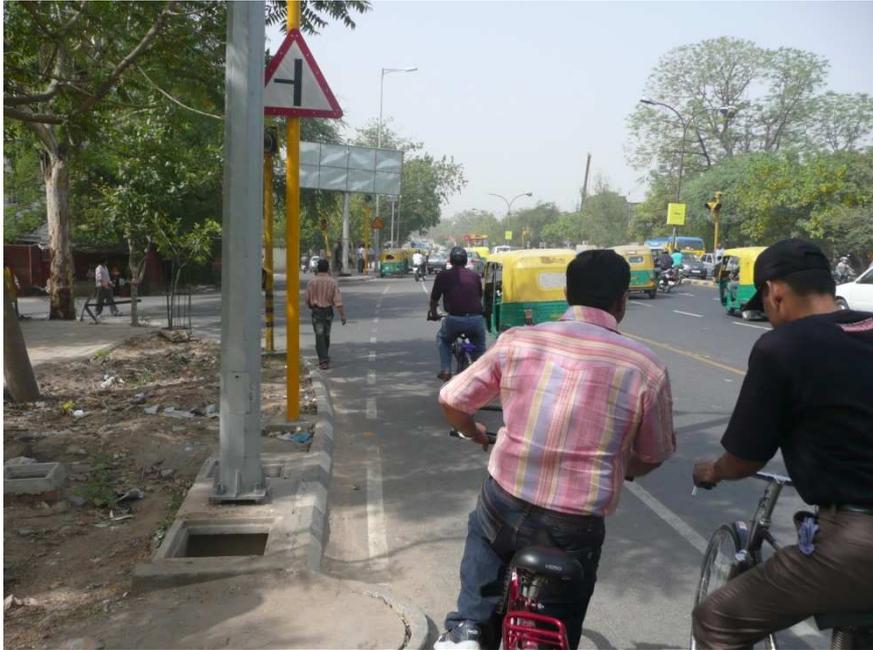
<p>OBSERVATION / PROBLEM IDENTIFIED</p>	<p>Raised crossing missing. Cyclists in conflict with entering and exiting traffic from left – Jangpura.</p>
<p>IMPLICATION</p>	<p>Unsafe. Cyclists would never use the segregated facility.</p>
<p>SOLUTION</p>	<p>All auditors agreed that raised crossing as per standard design in 80mm thick red colour CC tiles was an essential requirement for the bicycle infrastructure and can easily be constructed at all free turning locations including this one. Sandeep added that the design of a raised crossing is included in the drawings for this location already available with Rites. If the same is followed along with other solutions of developing segregated tracks ahead and behind (see points above) then a safe and usable facility can be developed with higher chances of used.</p>
